2016 Monitoring Report

April 2017

Report prepared by Lindsay Magranet
Siskiyou Resource Conservation District

For the
Scott River Water Trust

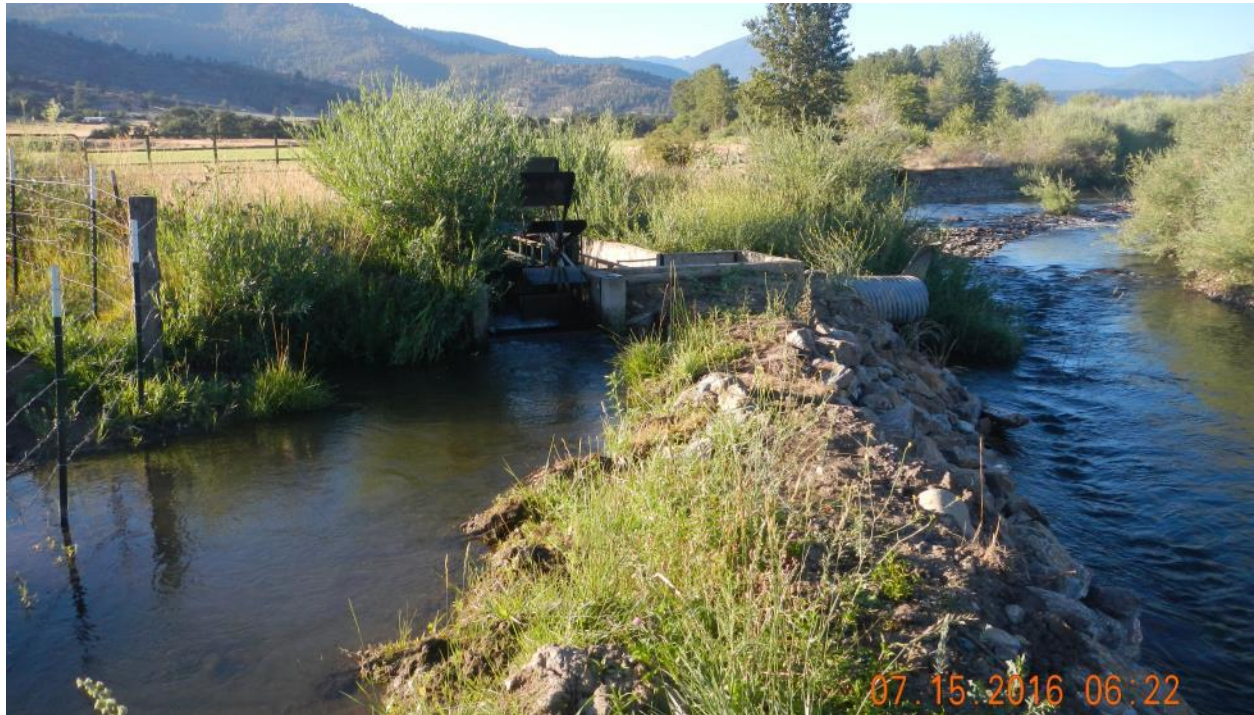
On the morning of July 15, 2016 the Contractor measured the total quantity of water being diverted through the rectangular suppressed weir exiting the fish screen as 1.86 cfs (Photo 1). A discharge measurement was taken downstream of the bypass culvert along a cross-section at the inflow of a run and streamflow through this channel of the Scott River was measured to be 23.59 cfs. At 8:30 a.m., all ditch flow was released to the Scott River by fully opening the bypass culvert and setting flashboards to prevent water from being diverted (Photo 2). At this site, flow passes through a section of ditch (approximately 990 feet) before returning to the Scott River through the fish screen bypass because there is not a headgate to completely prevent water from entering the point of diversion. Furthermore, in 2014, CDFW biologists determined that there was suitable habitat – cover and cold water – provided by this length of ditch that would be especially valuable for rearing salmonids during drought years when the adjacent section of the Scott River channel is at risk of going subsurface. After the diverted water was returned instream, flow along the same cross-section of the Scott River channel was measured to be 25.96 cfs. Streamflow monitoring verified an instream benefit of 2.37 cfs on July 15th as a result of this transaction.

Photo 1. Flow being diverted through the fish screen (left of photo) before the lease was initiated.

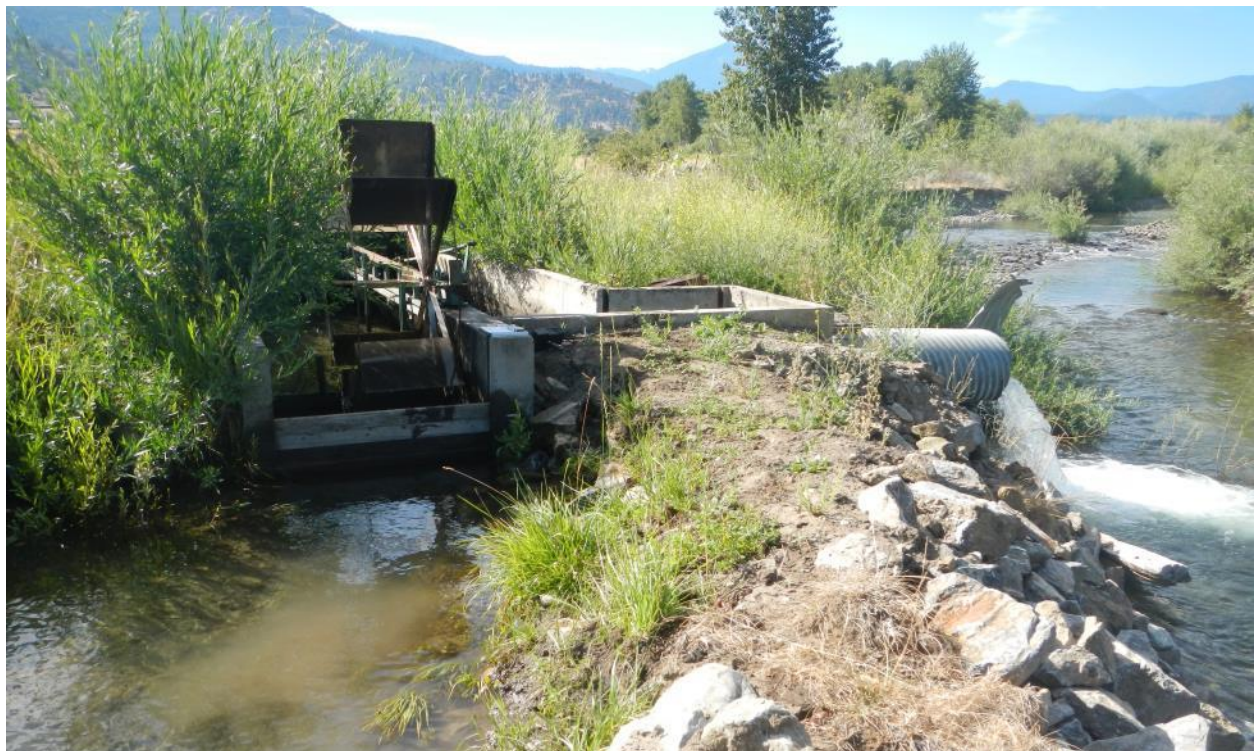
Photo 2. Flow being bypassed into the Scott River (right of photo) after the lease was initiated.

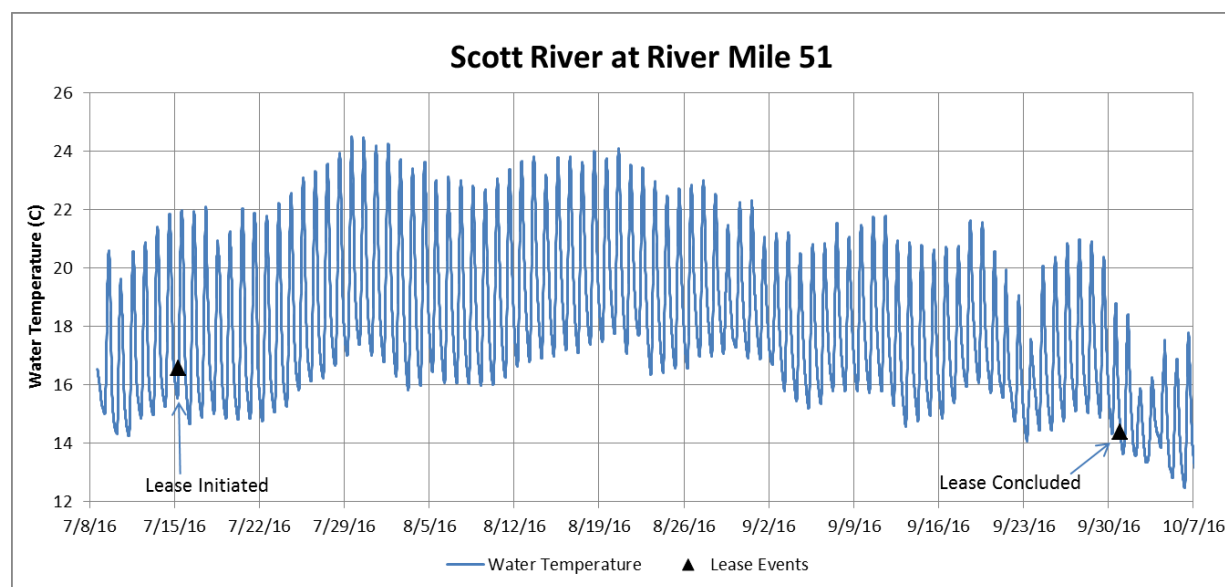
Prior to the initiation of a transaction at SR196, a water temperature logger was deployed off the river-right bank 140 feet downstream of where the diversion bypass flows re-enter the Scott River. Water temperature data was collected at this site from July 8th through October 12th. The logger was located on the stream margin at approximately 2 feet deep in a micro pool habitat underneath a willow cluster with southern exposure. Figure 1 shows water temperature data encompassing the duration of the SR196 water lease. The transaction began during a period where Scott River water temperatures were relatively high, but stable, before they inclined towards the seasonal maximum on July 29th. Analysis of water temperatures through the immediate days surrounding the initiation of the transaction confirm that the return of leased water did not affect the daily fluctuation of stream temperatures (Figure 2).

Figure 1. Water temperature data for the duration of the SR196 lease period.

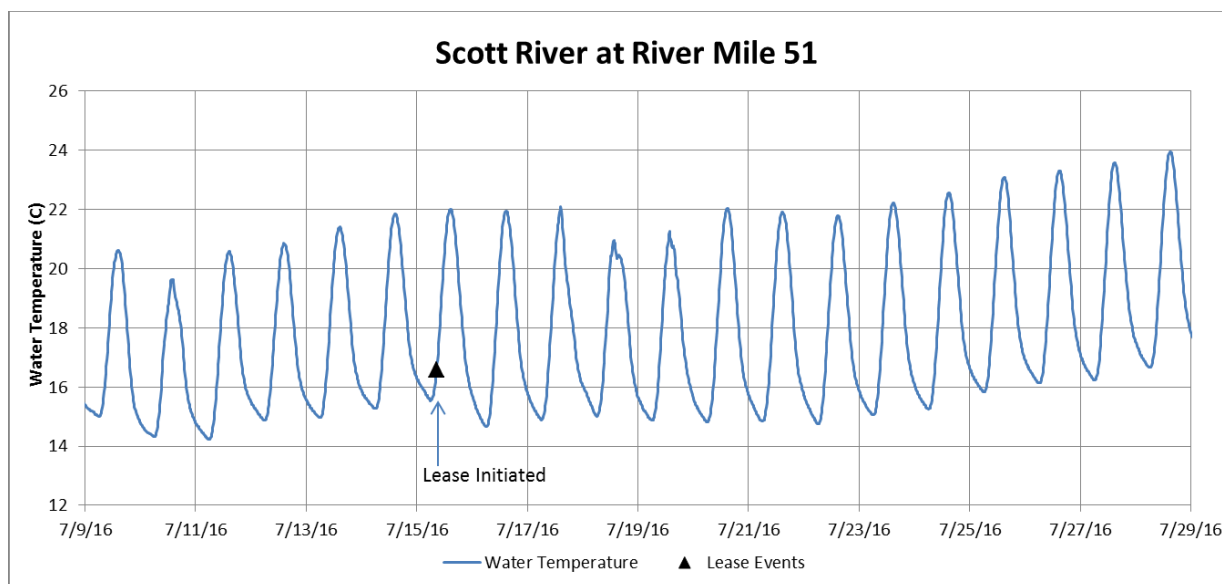
Figure 2. Water temperature data surrounding the initiation of the SR196 lease.

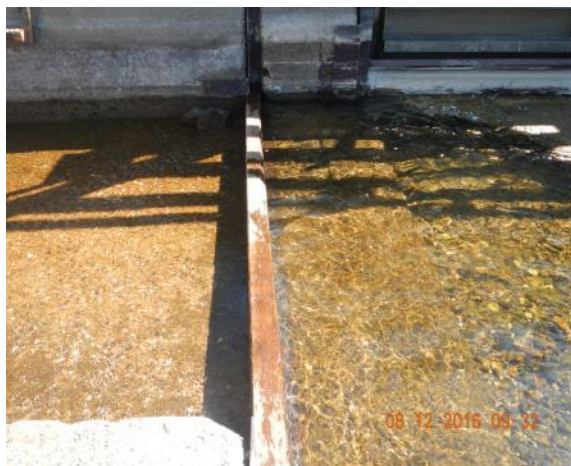
Photo 3. Flow passing into the fish ladder before the lease was initiated.

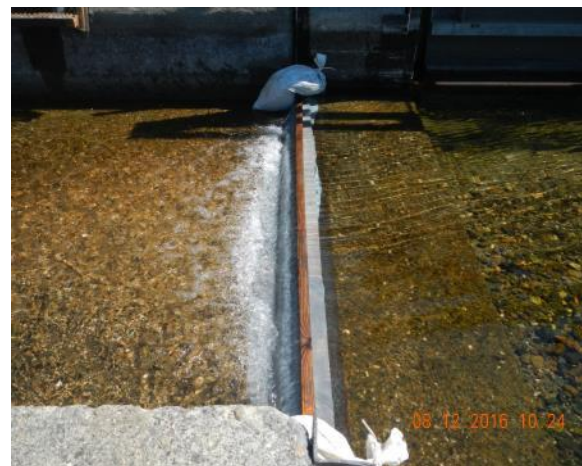
Photo 4. Flow passing into the fish ladder after the lease was initiated.

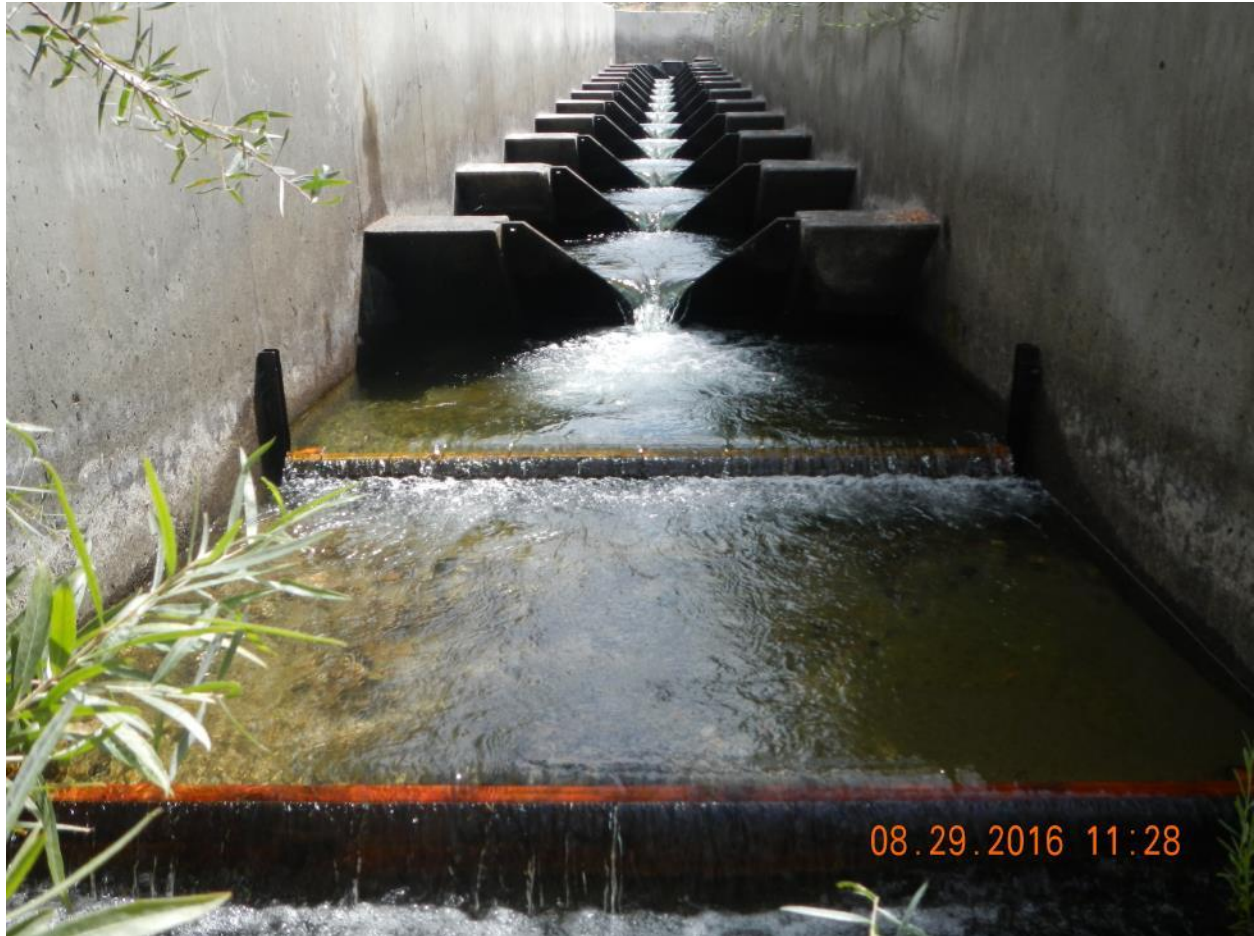
Monitoring of this transaction consisted of checking flow over the rectangular weir within the fish ladder and adjusting the headgate as needed to maintain the targeted flow. Between the Water Trust Executive Director and the Contractor, the point-of-diversion was visited three times per week until September 2nd when the headgate had to be fully closed to maintain the terms of the transaction. Despite flow becoming available for diversion later in September, the water user decided to leave the headgate closed and forgo the remaining water without additional compensation.

Photo 5. The full 1.5 cfs of leased water passing through the fish ladder.

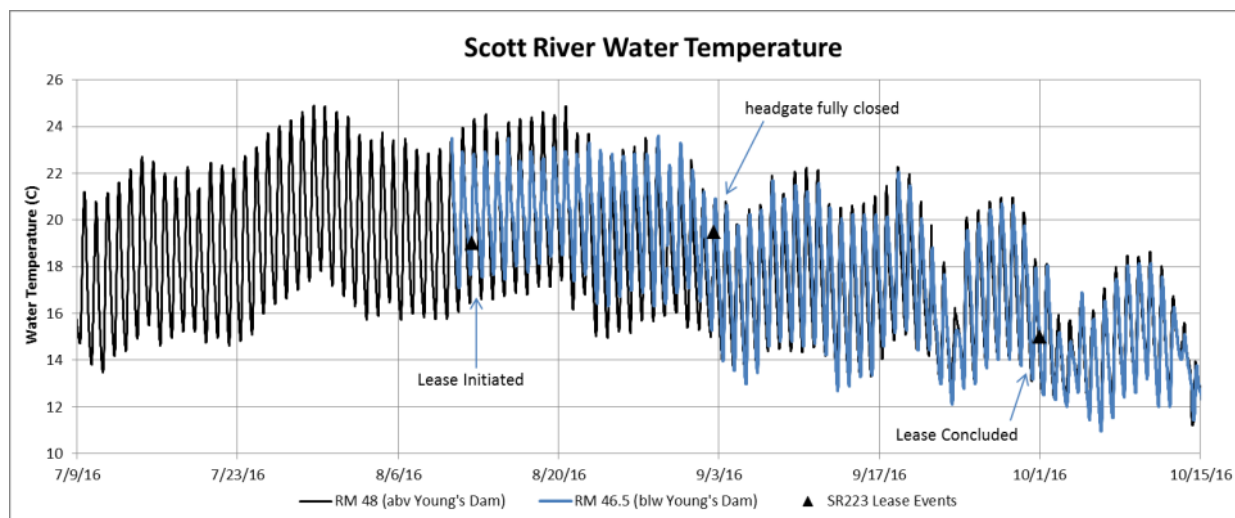
Water temperature monitoring in relation to the transaction at SR223 was performed at the River Mile 46.5 streamflow gaging station maintained by the Siskiyou RCD, which is situated on the river right margin of the run immediately below Young's Dam (Map 2). This station responds relatively quickly to alterations made at the diversion, however, it is subject to southern exposure. Water temperature data was recorded at this site for the SRWT from August 10th through October 25th. The Siskiyou RCD also collects well-mixed water temperatures on the Scott River at River Mile 48 (above Young's Dam) for trend monitoring purposes (Map 2). Figure 3 compares the water temperature data collected on the Scott River at River Mile 46.5 (below Young's Dam) and River Mile 48 (above Young's Dam) over the duration of the SR223 water lease. The River Mile 48 site identified peak water temperatures on July 29th, August 20th and August 13th. The transaction at SR223 was initiated on August 12th as water temperatures were on the rise. Closer analysis of this time period indicates that the augmentation of flow from the transaction noticeably stabilized water temperatures (Figure 4). From August 23rd onward, the water temperatures at RM 46.5 and RM 48 are nearly equal. Closing of the headgate on September 2nd did not appear to influence stream temperatures.

Figure 3. Water temperature data for the duration of the SR223 lease period (Siskiyou RCD).

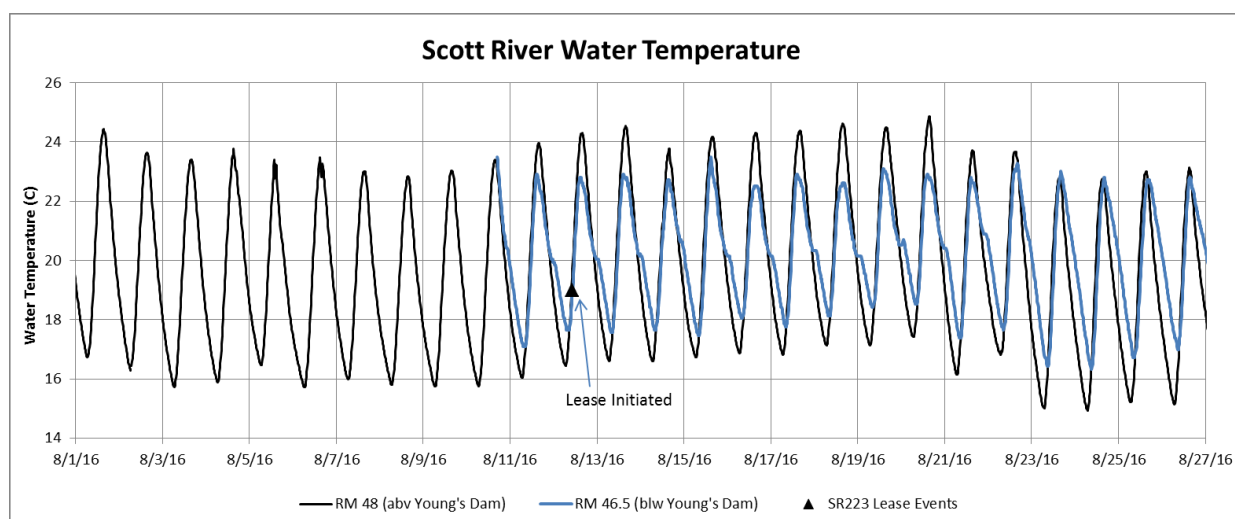
Figure 4. Water temperature data surrounding the initiation of the SR223 lease (Siskiyou RCD).

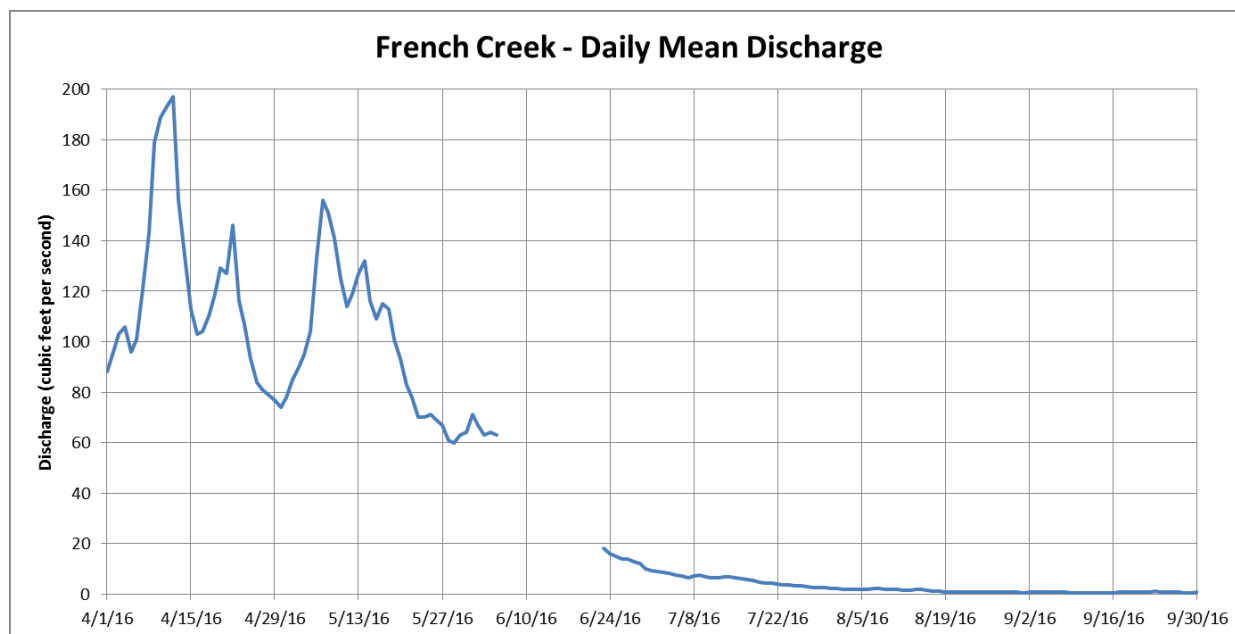
CDWR operates a streamflow gaging station on French Creek just upstream of State Highway 3 at river mile 0.8. Figure 5 shows daily mean discharge at the French Creek gaging station through the 2016 irrigation season, April 1st to September 30th. The season began with runoff from several rain events in April and May. A single precipitation event accumulated 0.34 to 0.71 inches between April 9th and April 14th, which accounted for the peak in runoff (CAL FIRE 2016, USFS 2016). The base flow period started in early August, with daily mean discharges reaching a minimum of 0.6 cfs (CDWR, 2016a). Rainfall finally came on October 13th and reconnected French Creek to the Scott River. It is important to note that FR48 is downstream of the CDWR gage, therefore, diversion and bypass of flows at this site do not contribute to the recordings made at that station.

Figure 5. Daily mean discharge on French Creek at RM 0.8 through the 2016 irrigation season (CDWR 2016a).

*Note: This gage was not funded from June 6th through June 22nd and therefore the data recorded within that time period is not supported by CDWR.

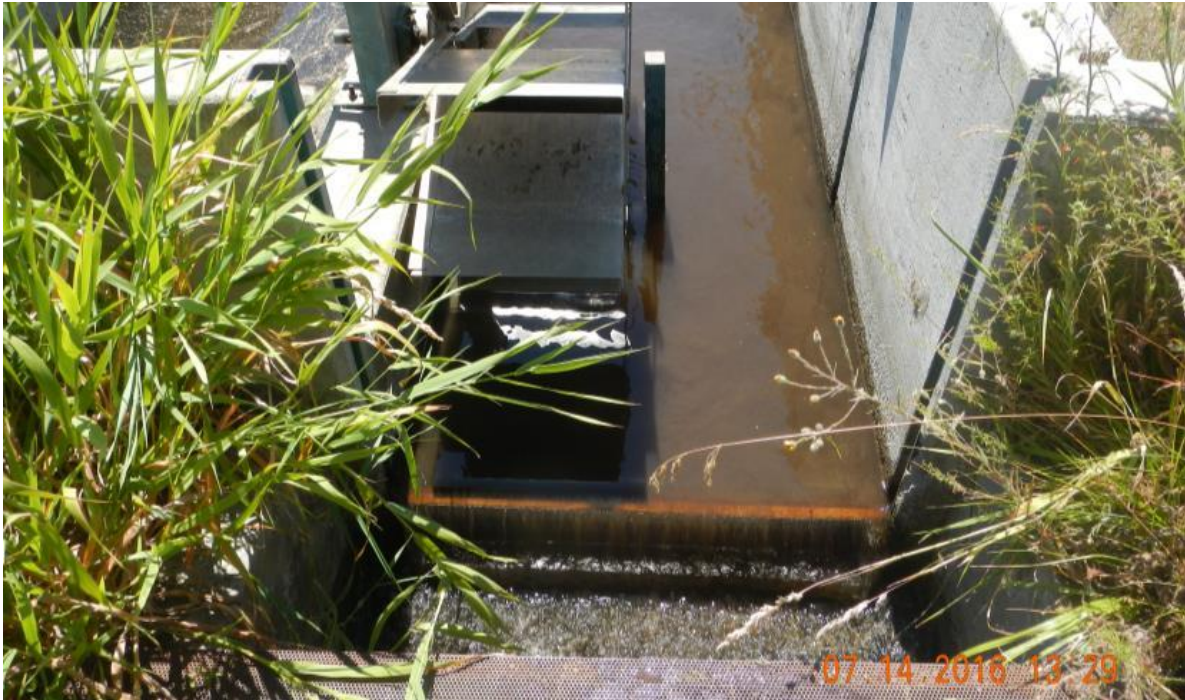
A forbearance agreement was signed on July 14, 2016 and that afternoon the quantity of water being diverted measured 0.74 cfs through the rectangular suppressed weir exiting the fish screen (Photo 7). There is not a sufficient location to measure discharge on French Creek downstream of where the diversion bypass returns to the stream as a result of thick emergent aquatic vegetation and channel morphology. However, flow at that location could be estimated by measuring discharge above the point of diversion and subtracting the quantity being diverted. Utilizing this reasoning, a measurement taken in French Creek immediately above the point of diversion recorded 6.63 cfs, which suggests that 5.89 cfs remained instream below FR48 before the transaction. The amount of water entering the ditch at the point of diversion and being bypassed at the fish screen was not quantified. The headgate could not be closed because fish removal from the ditch had not yet been coordinated, so the transaction was initiated at this site by fully opening the screen bypass. Flashboards were installed to prevent water from being diverted and all remaining ditch flow was returned to the stream by way of the bypass pipe. Diversion bypass flows re-enter the stream 490 feet below the point-of-diversion. It was confirmed that no flow was

Photo 7. Pre-lease diverted flow measured at 0.74 cfs.

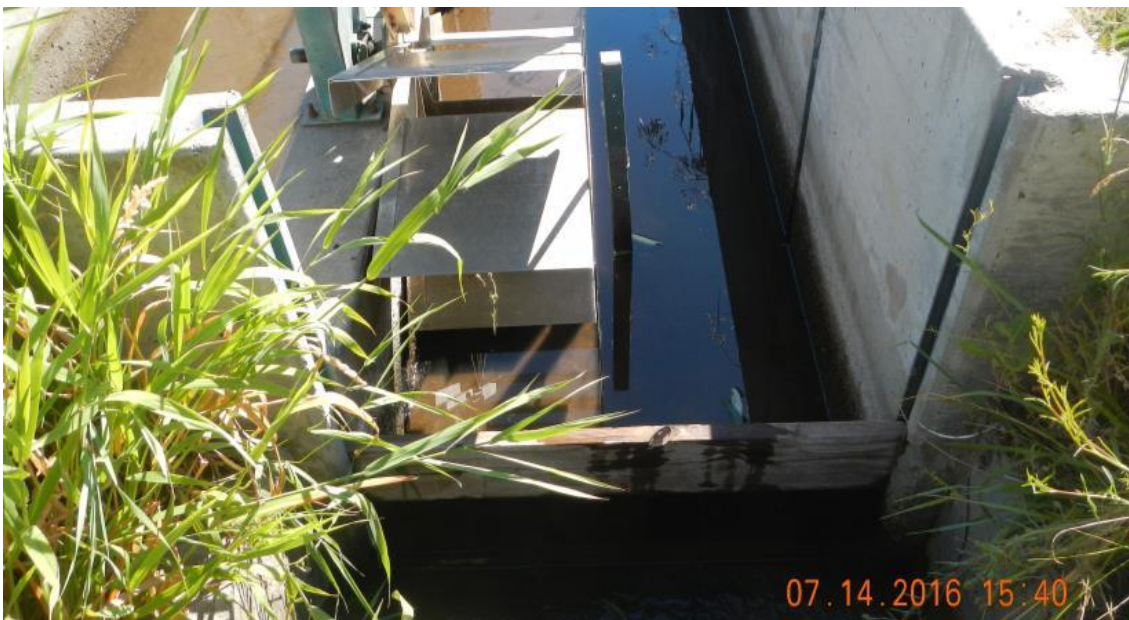
passing through the fish screen at 3:15 p.m (Photo 8). The SRWT Executive Director, in conjunction with CDFW personnel, returned to the site on August 3rd to relocate fish from the section of ditch between the point-of-diversion and fish screen, which allowed for the headgate to be closed.

Photo 8. Post-lease flow through the fish screen ceased.

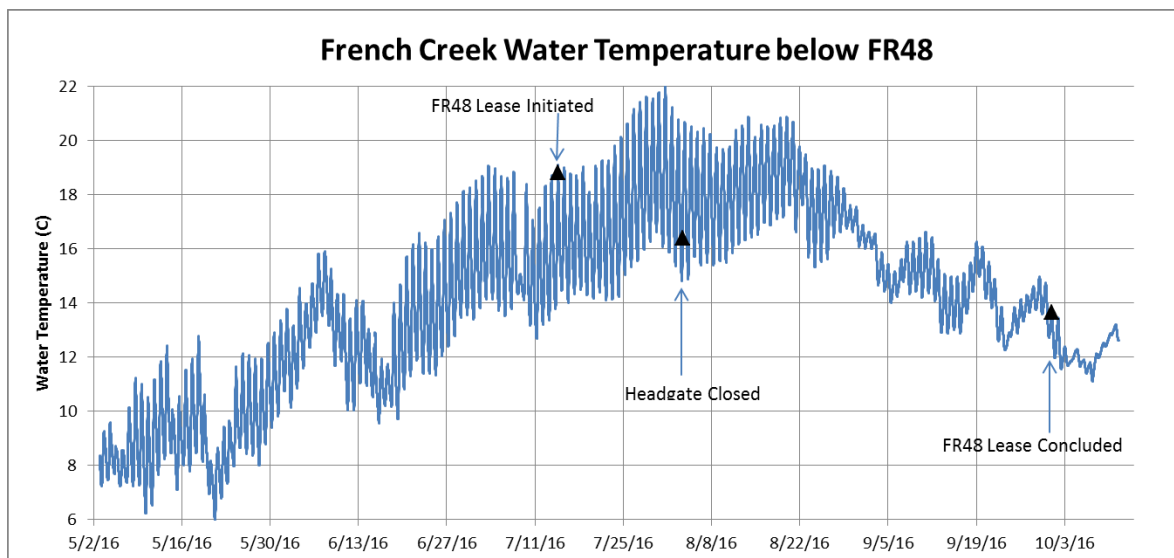
stable period right before water temperatures peaked on July 31st. Comparison of these values with recordings made by the RCD water temperature station on French Creek at river mile 0.65 (above FR48, Map 3) shows a divergence across part of the dataset (Figure 7). The timing suggests that the water transaction resulted in higher daily maximum temperatures until the headgate was closed on August 3rd and leased water was no longer running through an open faced ditch (Figure 7). The variance is likely visible between these datasets because the SRWT device was located right below the bypass pipe and encountered water before it had become well-mixed with the stream. Therefore, it is possible that the transaction only influenced the water temperature of a microhabitat.

Figure 6. Water temperature data for the duration of the FR48 lease period.

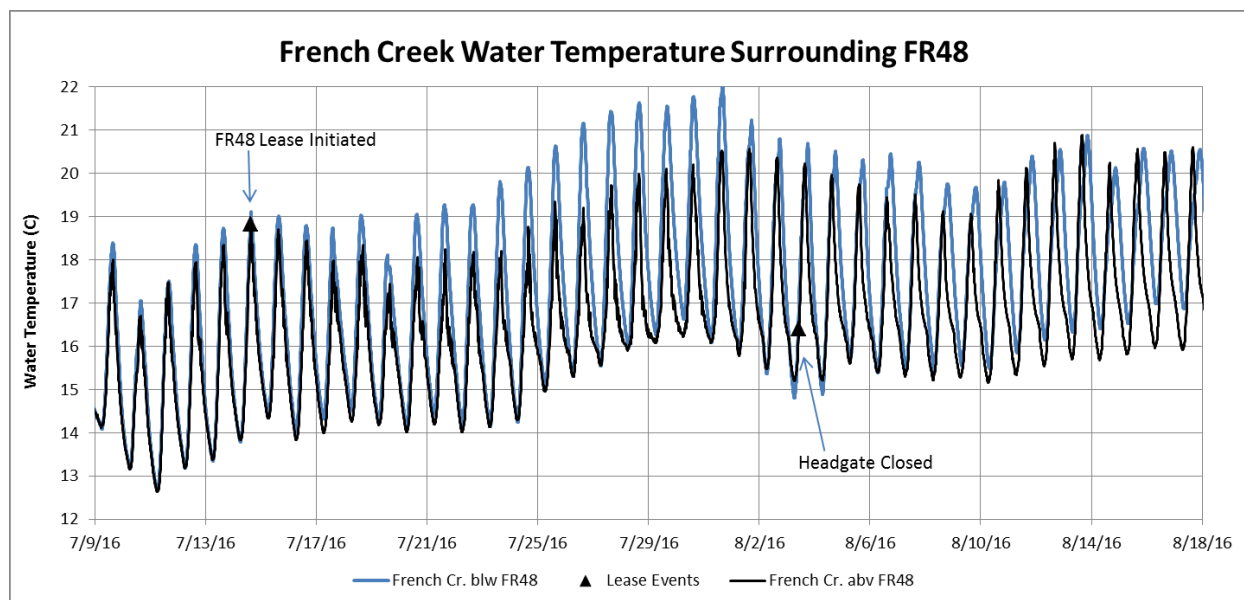
Figure 7. Water temperature data surrounding the initiation of the FR48 lease.

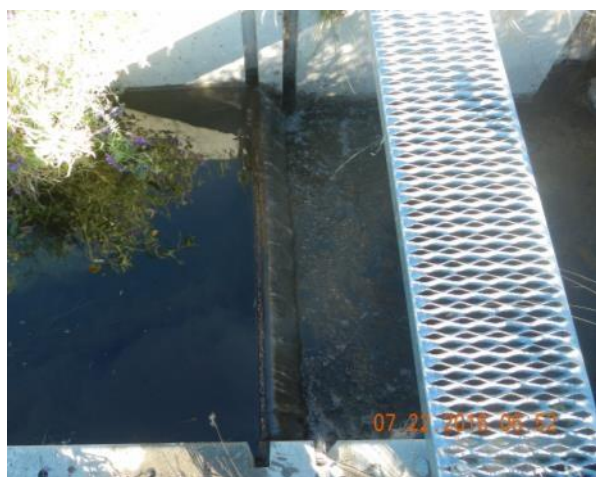
A forbearance agreement was signed by the user of both water rights and on the morning of July 22nd the Contractor measured 0.90 cfs being diverted through the rectangular contracted weir below the fish screen (Photo 9). Due to the fact that fish removal from the ditch had not yet been coordinated, the transaction was planned to be initiated at this site by fully opening the screen bypass. It is important to note that this diversion has a relatively long length of ditch from the point-of-diversion to the fish screen, approximately 980 feet. As a result, water that is bypassed as part of normal operation of the fish screen returns to French Creek just below State Highway 3, which bypasses the CDWR Streamflow Gaging Station. In order to accurately quantify the instream benefit of this transaction, streamflow was measured at the tail-out of the glide where bypass flows are returned, about 90 feet downstream of the pipe. A pre-lease discharge measurement taken along this cross-section documented 4.32 cfs in French Creek. The total diverted amount of water was returned instream at 8:00 a.m. by adding flashboards to the ditch and fully opening the screen bypass (Photo 10). A streamflow measurement completed after the transaction verified that flow had increased to 5.71 cfs across the same cross-section. The net gain was found to be

Photo 9. Pre-Lease diverted flow 0.9 cfs.

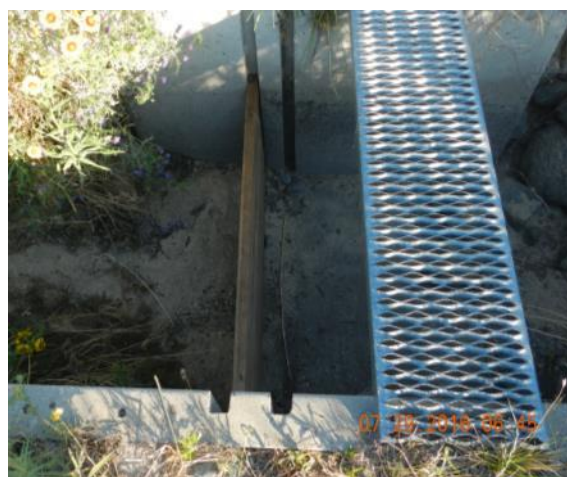
Photo 10. Post-lease diverted flow 0 cfs.

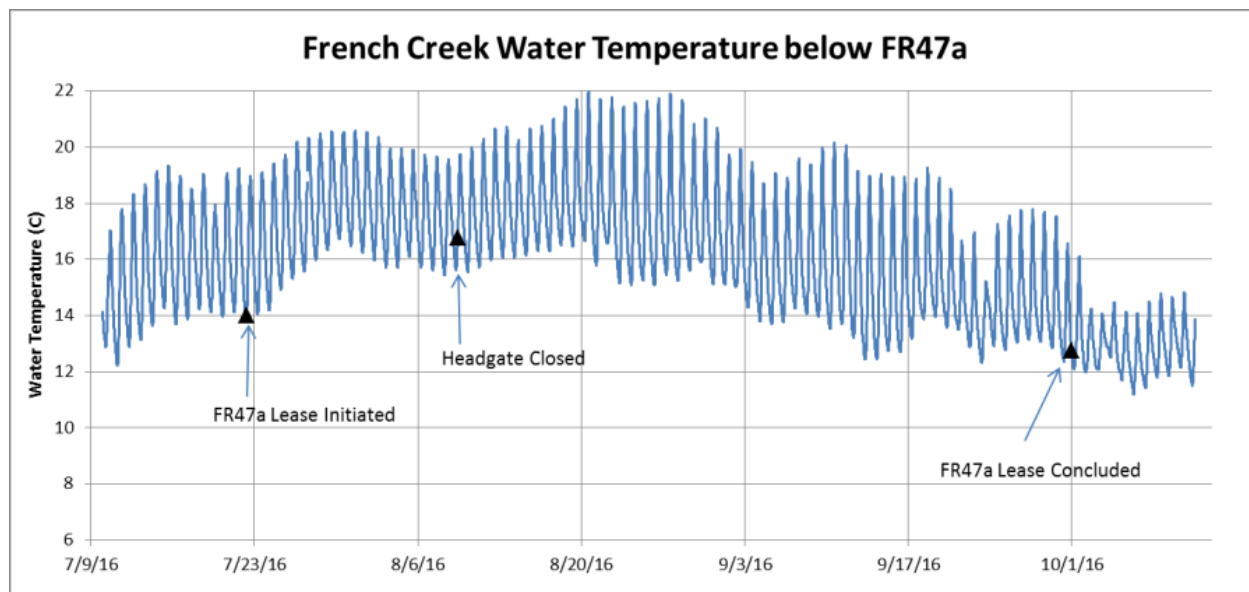
when the headgate was closed (Figure 9). The water temperature data above FR47a is from the RCD stream gaging station located approximately 160 feet above the point-of-diversion. The fact that these datasets track so closely demonstrates that the water temperature of French Creek was not affected by the transaction at FR47a. With the existing monitoring network there is no way to determine if the return of leased water through the fish screen bypass influenced water temperatures on French Creek.

Figure 8. Water temperature data for the duration of the FR47A lease period.

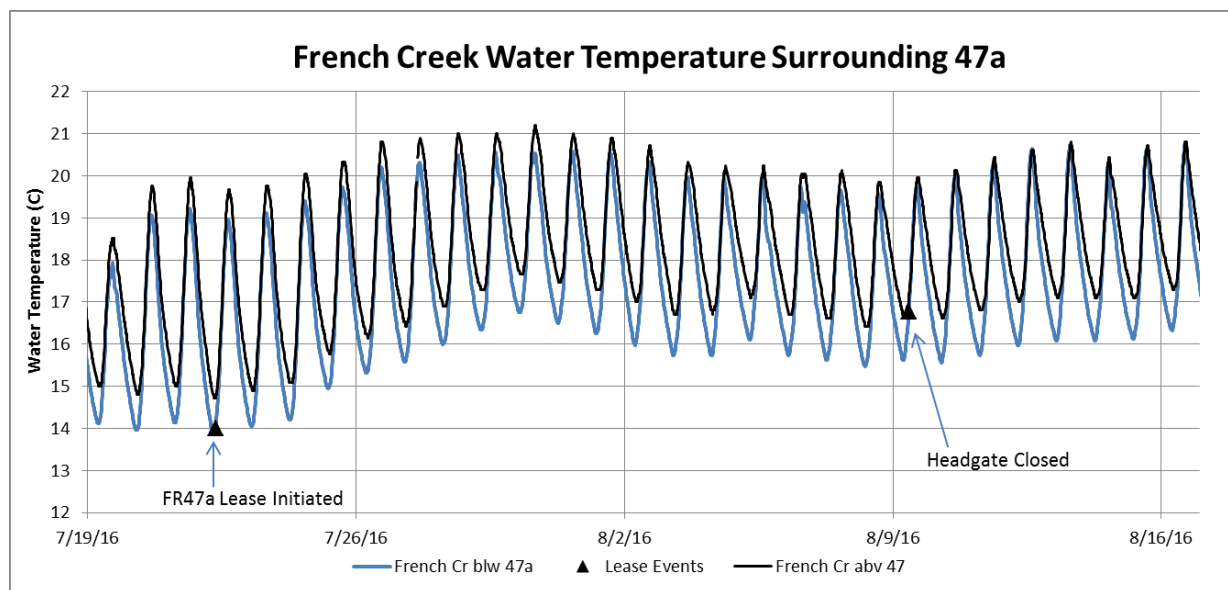
Figure 9. Water temperature data surrounding the closing of the headgate at FR47a.

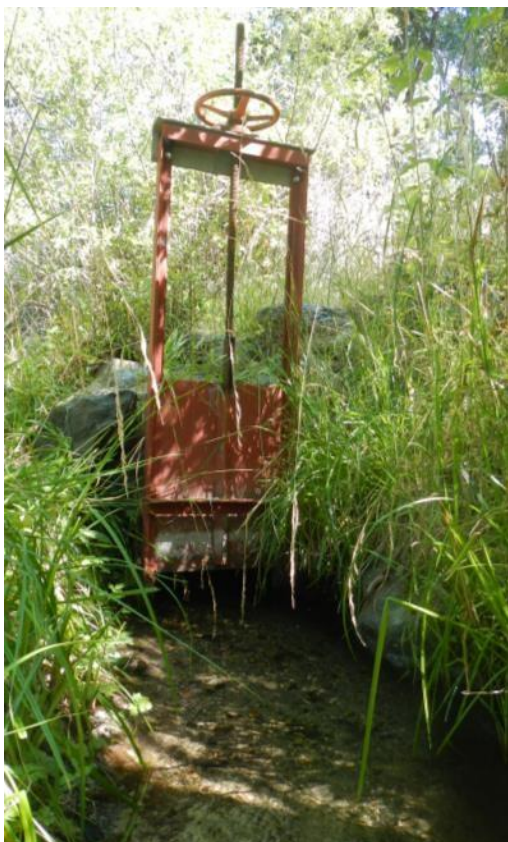
Photo 11. Pre-lease headgate open.

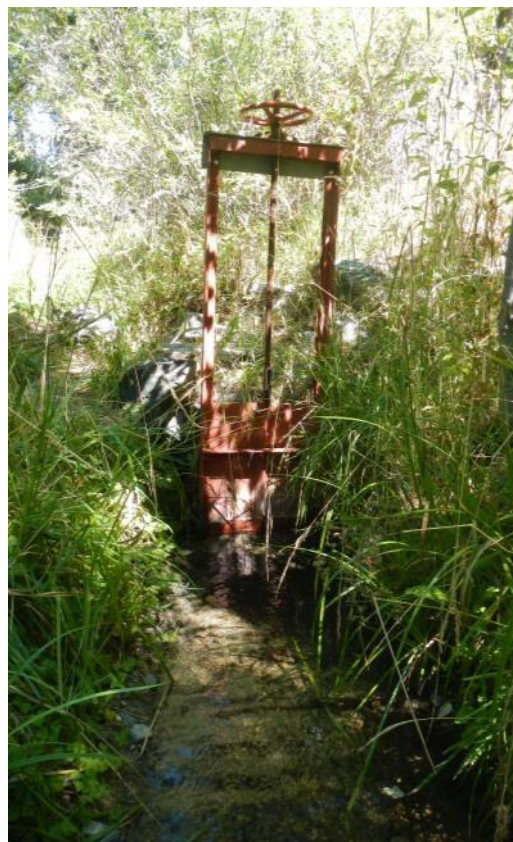
Photo 12. Post-lease headgate fully closed.

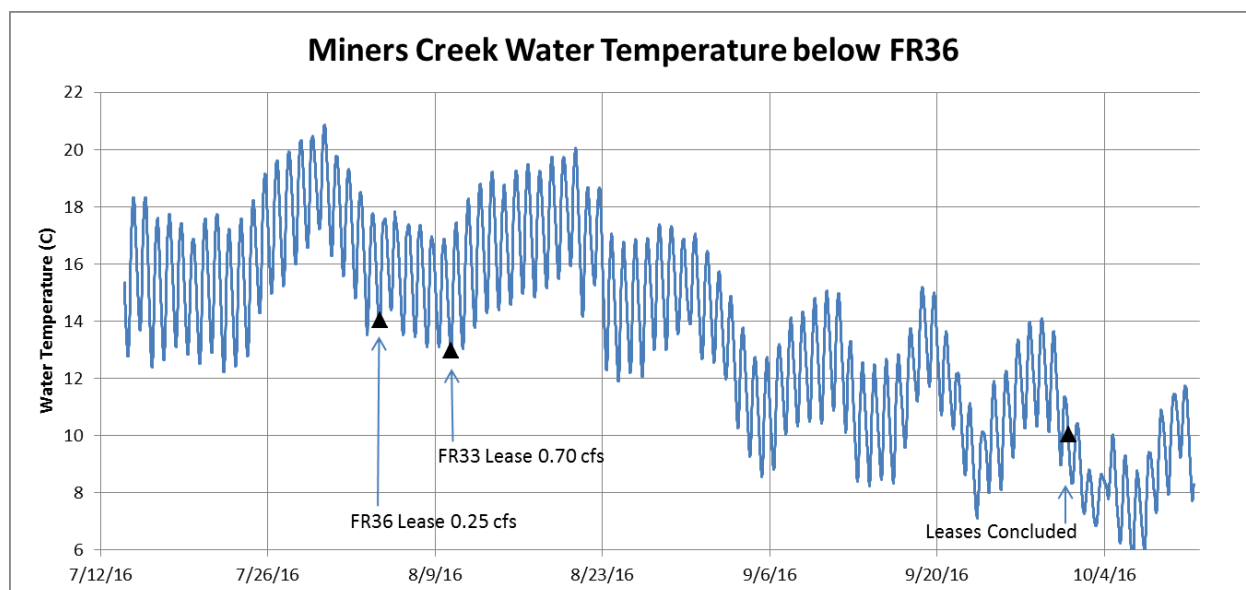
A water temperature device was placed in the deepest part of the plunge pool created by the vortex boulder weir, 25 feet below the point-of-diversion (same pool as previous years). Although the device was deployed into the lower portion of the water column, it likely received some well-mixed water dispersed from the boulder spillway. Water temperature data was collected at this site from July 14th through October 11th (Figure 10). The FR36 lease was initiated on the downward limb from the seasonal maximum temperature, which was recorded on July 30th as 20.9 C. Comparison of water temperatures from Miners Creek with the adjacent reach of French Creek reveal that the two track closely and demonstrates that there was not a visible influence on water temperature as a result of this transaction (Figure 11).

Figure 10. Water temperature data from Miners Creek for the duration of the FR36 and FR33 lease periods.

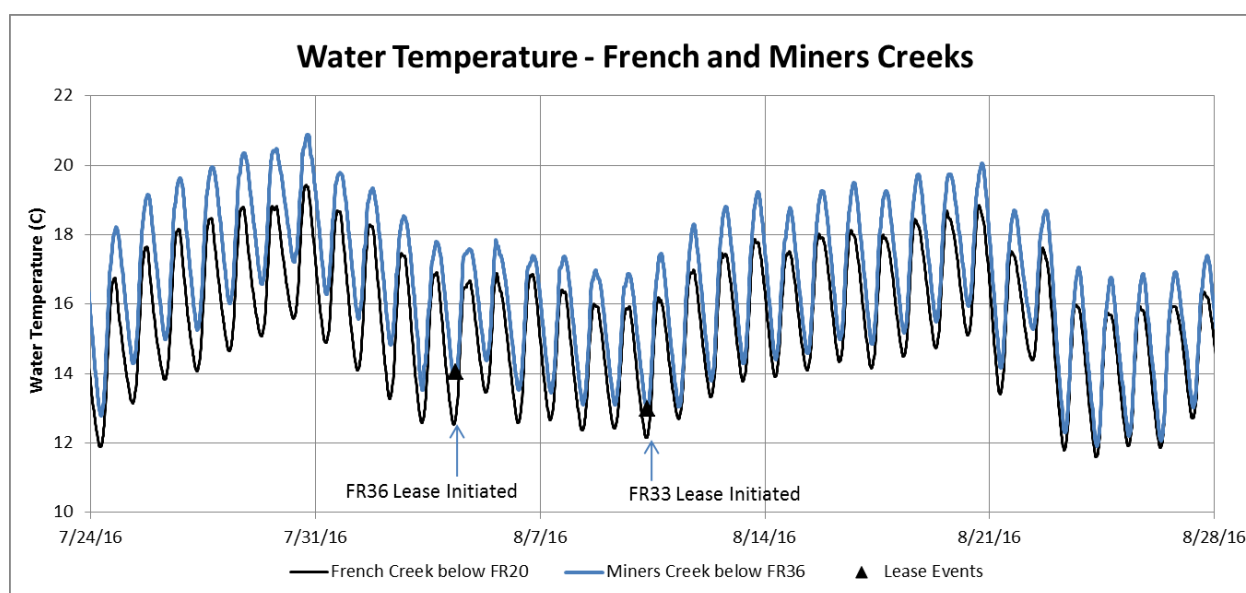
Figure 11. Comparison of water temperature on French Creek (above Miners Creek) and Miners Creek.

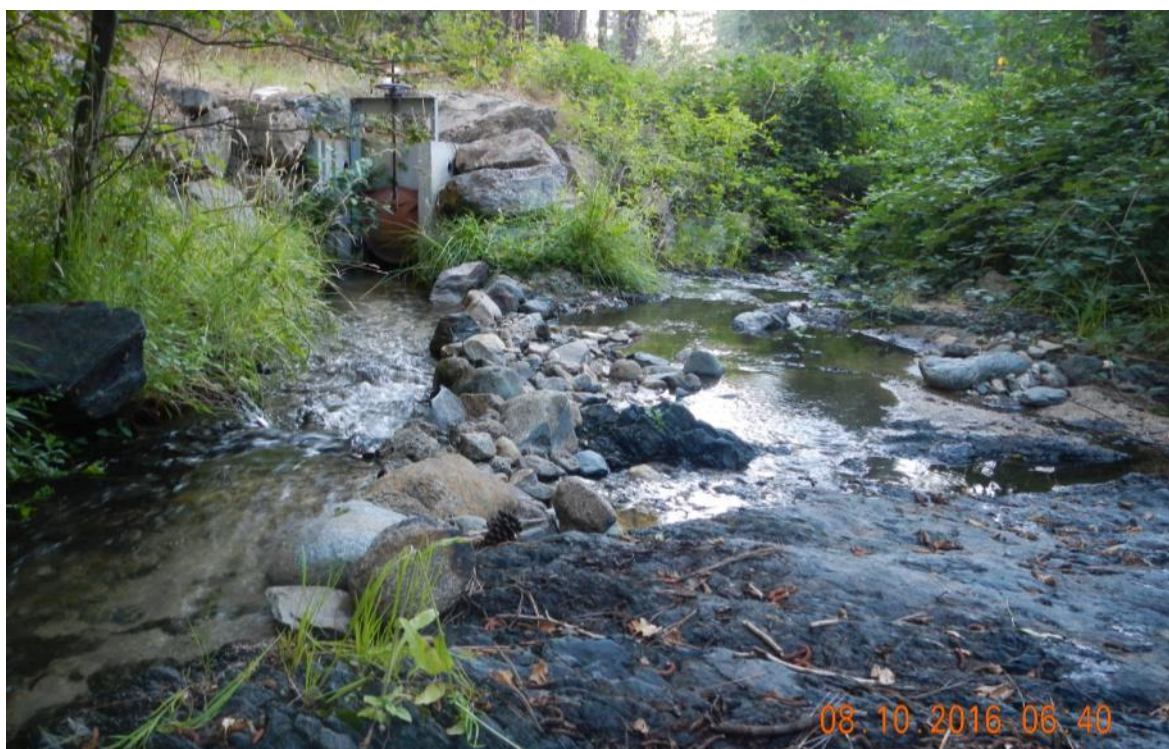
A forbearance agreement was signed on August 10, 2016, and that morning the Contractor measured the diverted flow to be 0.70 cfs on the rectangular contracted weir situated within the ditch, immediately below the fish screen. A cross-section was established on Miners Creek, 265 ft. below the point-of-diversion and downstream of the screen bypass return pipe, where a flow measurement was conducted recording 0.12 cfs. The Water Trust Executive Director, in coordination with the water user, lowered the headgate in several intervals and fish relocated was coordinated privately. The headgate was fully closed at 8:10 a.m. and the hand-stacked dam at the point-of-diversion was adjusted to allow flow to access the stream channel (Photo 13 and 14). A follow-up stream flow measurement recorded 0.86 cfs in Miners Creek. This transaction resulted in a measureable net instream benefit of 0.74 cfs after the initiation of the lease.

Photo 13. Miners Creek at the FR33 POD before the lease, headgate open.

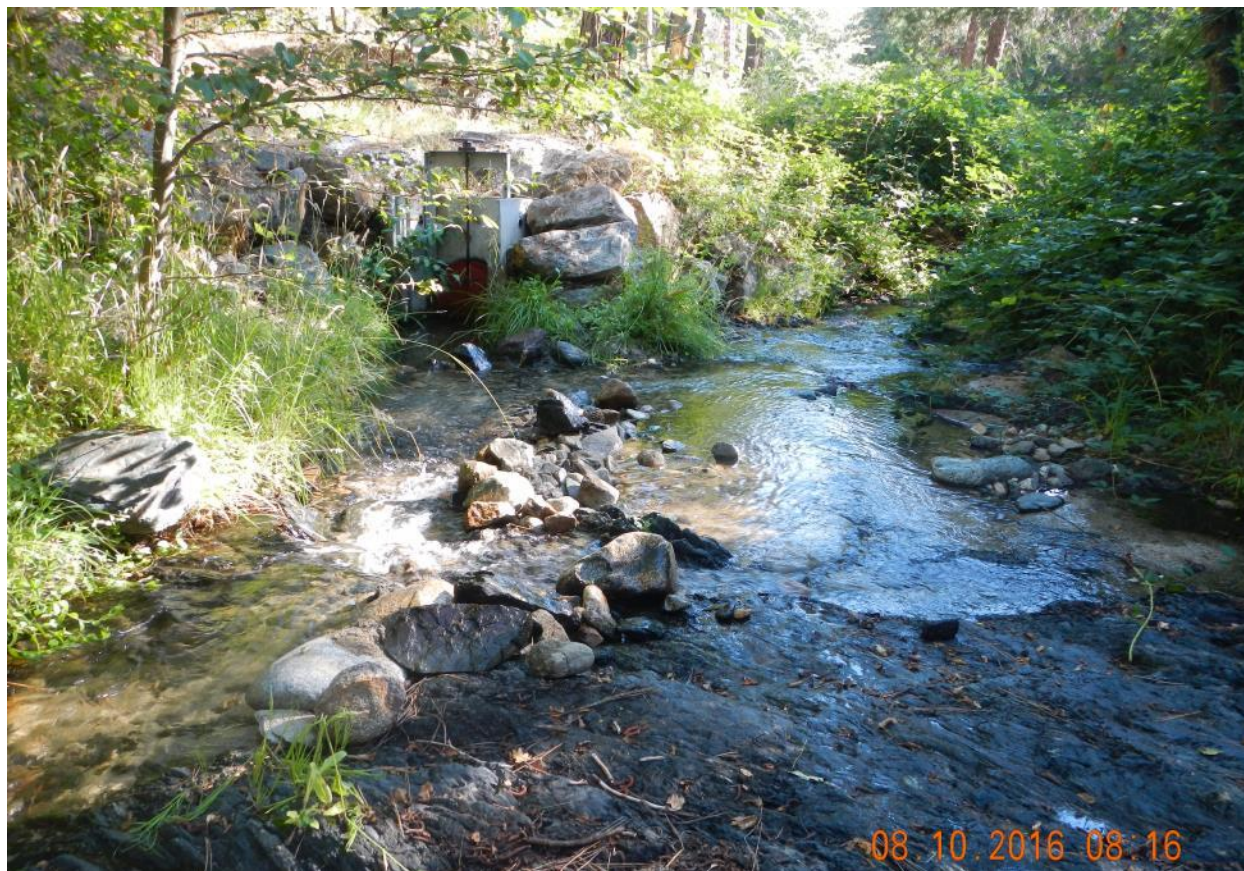
Photo 14. Miners Creek at the FR33 POD after the lease, headgate closed.

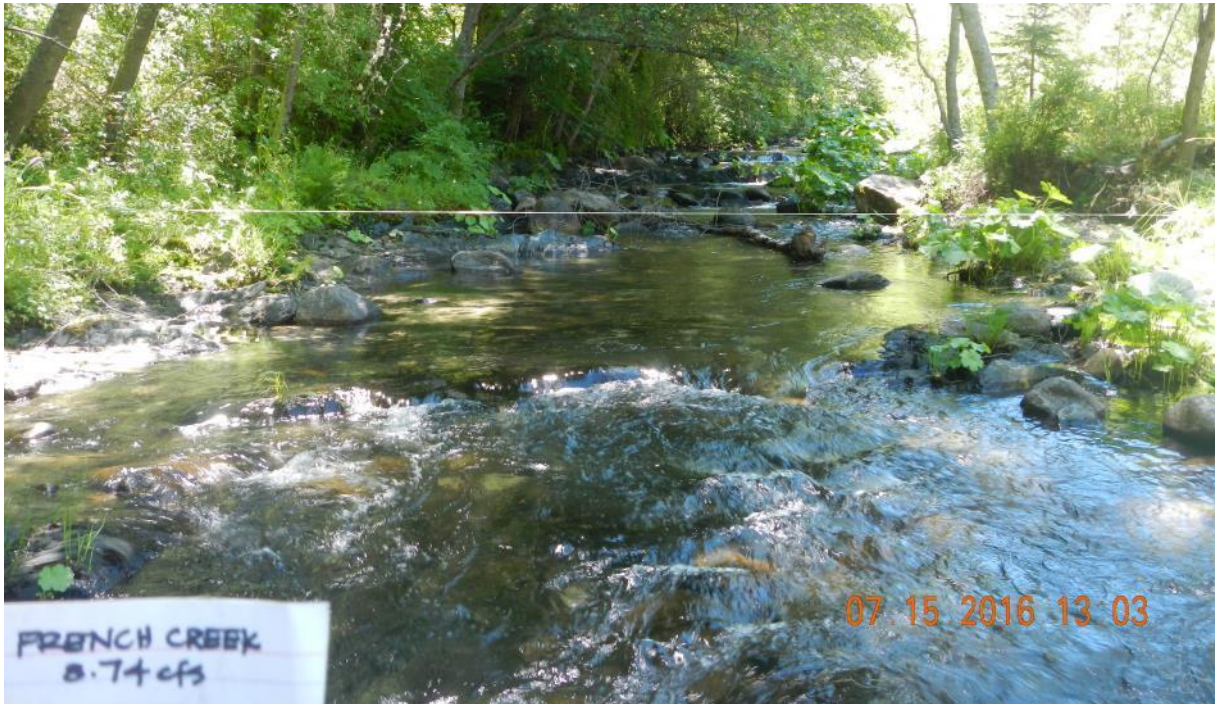
verifying the release of 0.76 cfs at the headgate, the French Creek cross-section only responded with an increase of 0.26 cfs on the afternoon of July 15th. The discrepancy between these measurement sites may be due to the daily fluctuation of flow on French Creek (natural afternoon decline) or the loss of water during the temporary rehydration of the secondary spillway.

Photo 15. Pre-lease streamflow measurement on French Creek recorded 8.74 cfs.

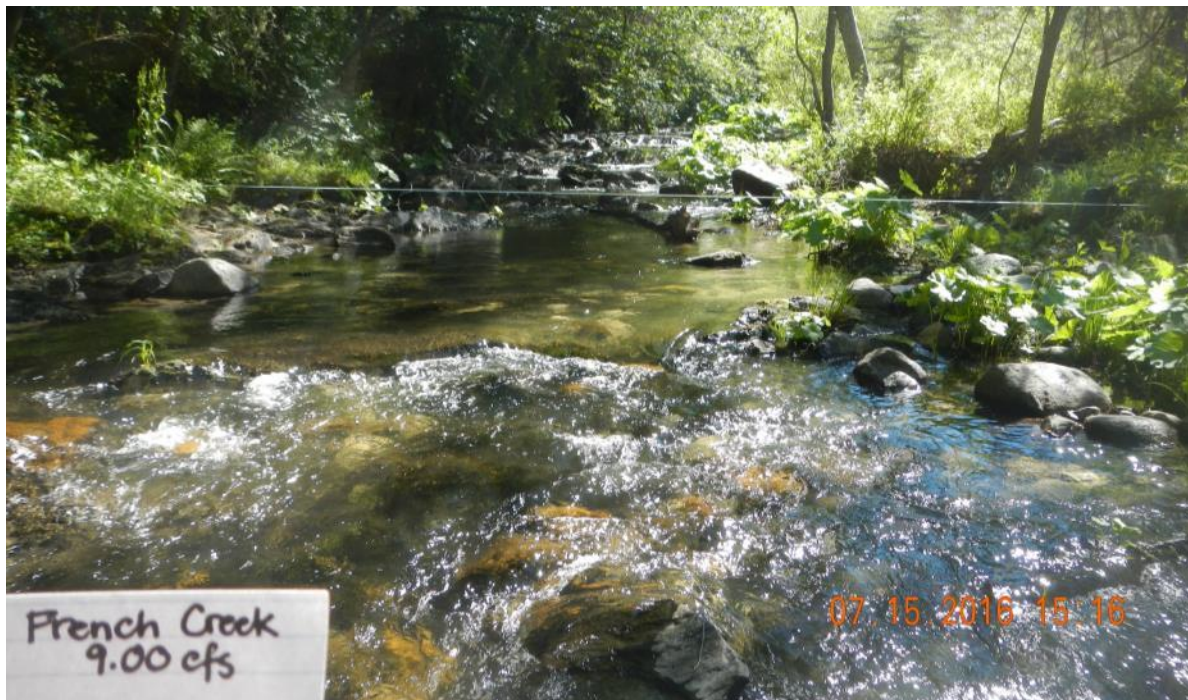
Photo 16. Post-lease streamflow measurement on French Creek recorded 9.00 cfs.

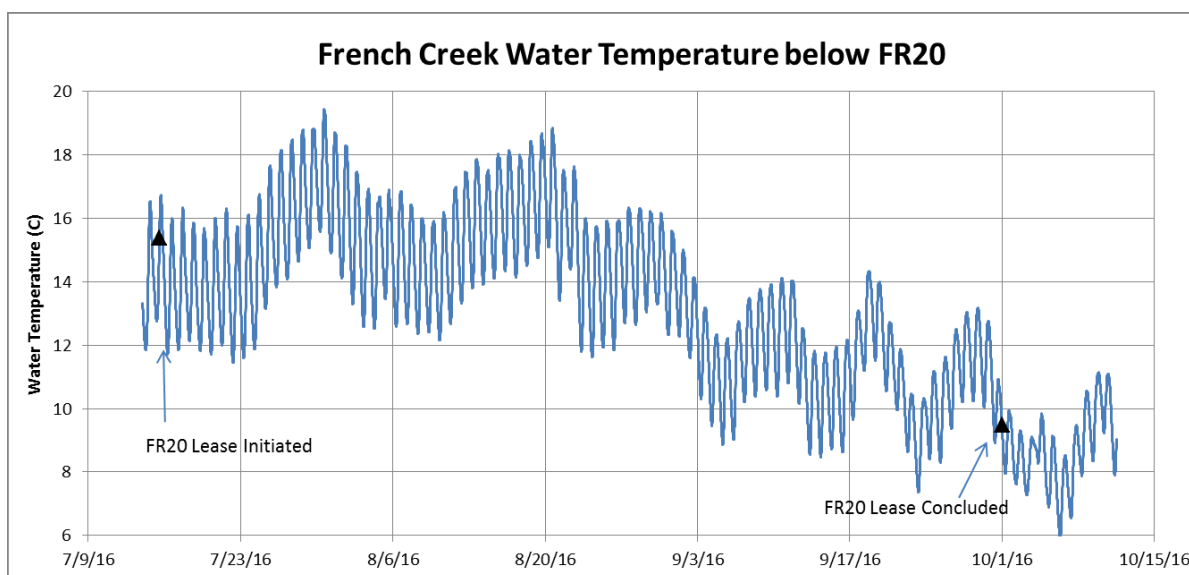
A water temperature logger was deployed off the river right bank of French Creek into the deepest portion of a pool habitat downstream of where FR20 bypass flows return to the stream. Juvenile salmonids were verified to be rearing in this habitat over the summer. Water temperature data was collected below FR20 from July 14th through October 11th (Figure 12). Comparison to water temperature data collected by the Siskiyou RCD at River Mile 2.3 on French Creek (below Miners Creek, Map 3) can be used to verify that the return of leased water did not impact local temperature conditions at FR20 (Figure 13). Although water temperatures were on an incline coming into this transaction, the datasets track very closely and the diurnal fluctuation was not altered, indicating that the returned water was not impacting the temperature regime of French Creek.

Figure 12. Water temperature data for the duration of the FR20 lease period.
