2016 Monitoring Report

April 2017

Report prepared by Lindsay Magranet
Siskiyou Resource Conservation District

For the
Scott River Water Trust

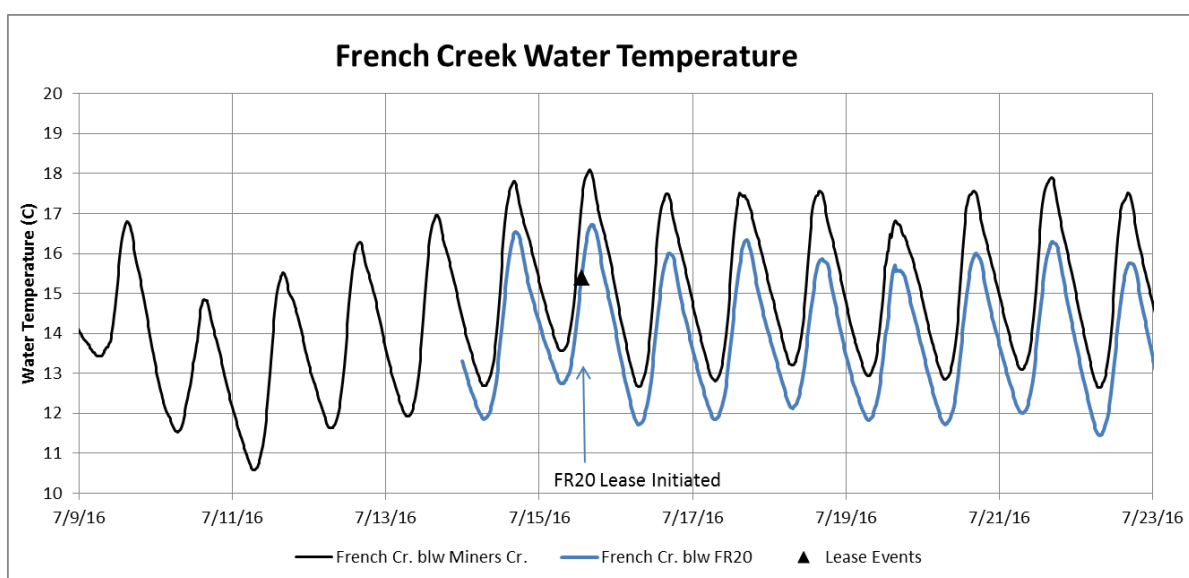
A water temperature logger was deployed off the river right bank of French Creek into the deepest portion of a pool habitat downstream of where FR20 bypass flows return to the stream. Juvenile salmonids were verified to be rearing in this habitat over the summer. Water temperature data was collected below FR20 from July 14th through October 11th (Figure 12). Comparison to water temperature data collected by the Siskiyou RCD at River Mile 2.3 on French Creek (below Miners Creek, Map 3) can be used to verify that the return of leased water did not impact local temperature conditions at FR20 (Figure 13). Although water temperatures were on an incline coming into this transaction, the datasets track very closely and the diurnal fluctuation was not altered, indicating that the returned water was not impacting the temperature regime of French Creek.

Figure 13. Water temperature data surrounding the initiation of the FR20 lease.

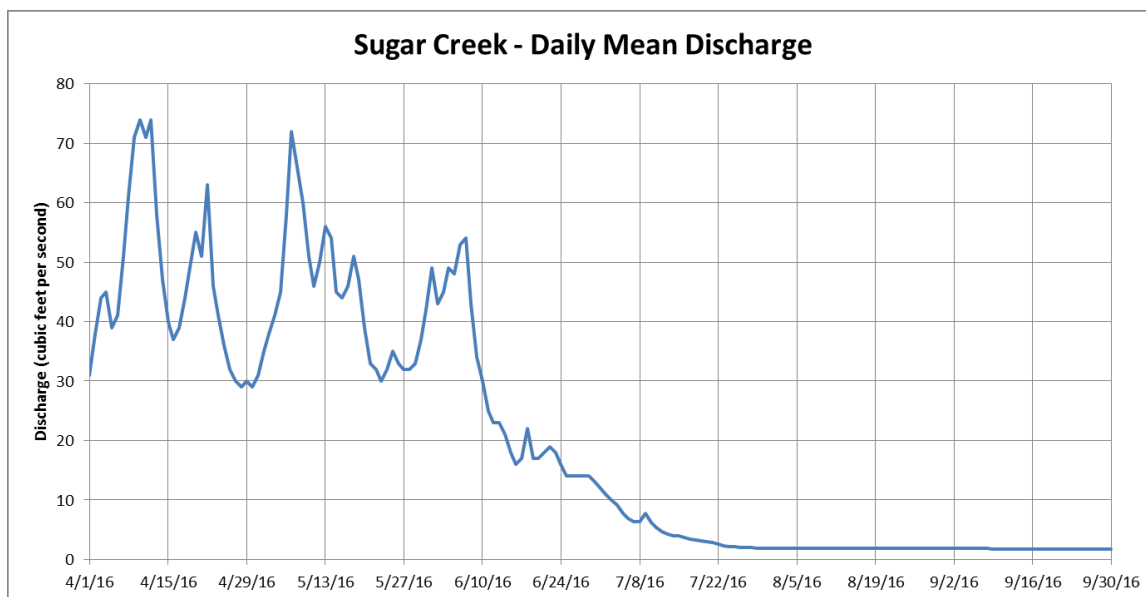
CDWR operates a streamflow gaging station on Sugar Creek at River Mile 1.6. Figure 14 shows daily average discharge at the Sugar Creek station through the irrigation season as defined by the Scott River Decree, April 1st to October 1st. Spring runoff is characterized by an oscillating stream response from precipitation events that accumulated 0.71 to 0.99 inches at nearly consistent intervals from April through May (USFS 2016). The base flow period started in late-July and extended through the remainder of the irrigation season, with daily average discharges hovering right around 2 cfs (CDWR 2016b). Sugar Creek sustained surface flow from the SG173 point of diversion to its confluence with the Scott River for the duration of the 2016 summer, although the river was disconnected through multiple reaches of the tailings.

Figure 14. Sugar Creek daily average flow at RM 1.6 through the 2016 irrigation season (CDWR 2016b).

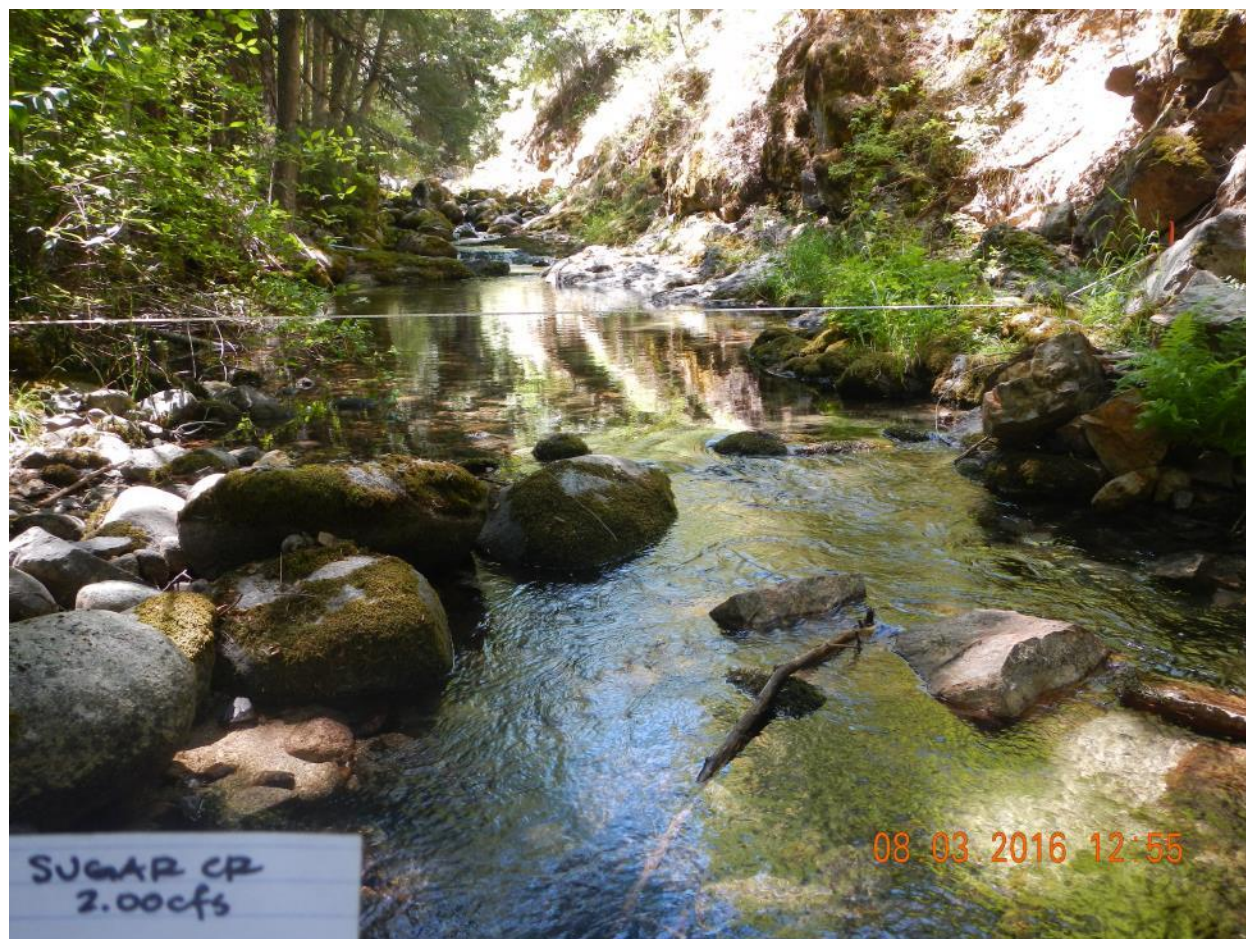
On the morning of August 3, 2016, the Contractor met with the Darbee Ditch water users to initiate a lease of the 3rd priority water right. Diverted flow was measured at 1.84 cfs across the rectangular contracted weir entering the pipeline, with 0.74 cfs belonging to the 3rd priority. A cross-section for discharge measurements was established on Sugar Creek 280 feet downstream of the point-of-diversion (below the fish screen bypass return pipe) to monitor the change in discharge as a result of this transaction. A flow measurement recorded 1.61 cfs in Sugar Creek (Photo 11). The Contractor, in coordination with the Darbee Ditch water users, then adjusted the headgate and fish screen infrastructure to reduce the diverted flow by 0.74 cfs, thereby returning the 3rd priority water right instream at the point-of-diversion. The lease target was met at 10:30 a.m. when flow entering the diversion pipeline was measured to be 1.1 cfs across the rectangular weir. A post-lease flow measurement taken along the same cross-section revealed 2.00 cfs in Sugar Creek (Photo 12). Despite the rectangular weir verifying the release of 0.74 cfs as a result of this transaction, the Sugar Creek cross-section only responded with an increase of 0.39 cfs on the afternoon of August 3rd. The discrepancy between these values is understood to be due to the fact that the pre- and post- streamflow measurements were taken several hours apart, which allows for the diurnal decline in flow to work against the augmentation provided by the lease. This is evidenced by the CDWR streamflow gage, which registered the quantity of water leased on August 3rd over a one hour time period in the middle of the afternoon when stage was naturally declining (Figure 15).

Photo 4. Post-lease streamflow measurement on Sugar Creek at RM 3.5.

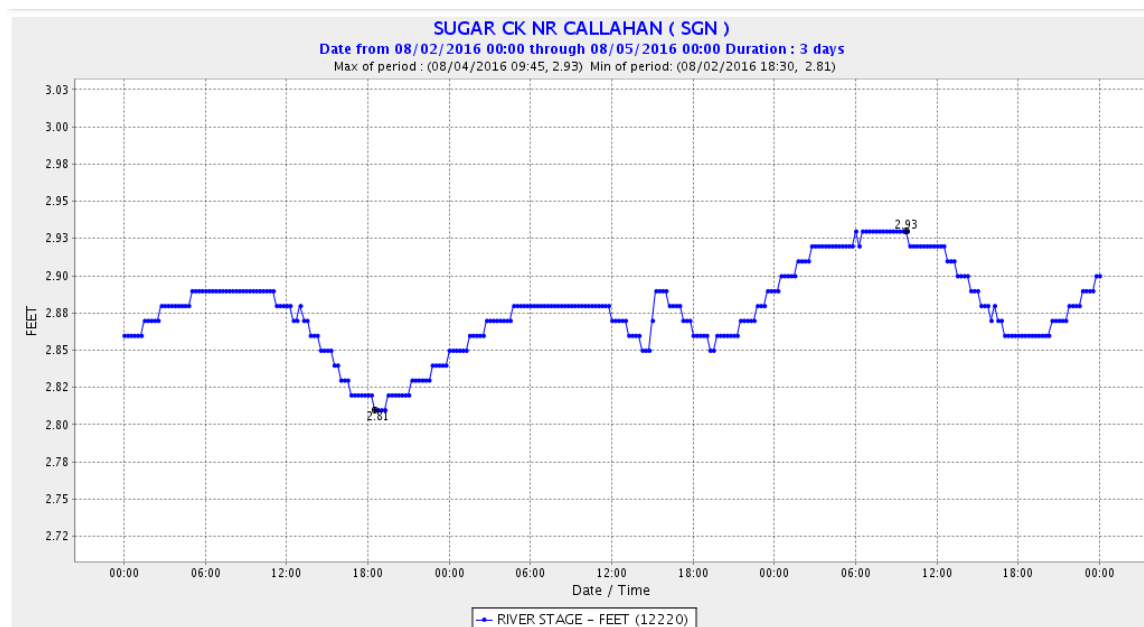
Figure 15. Sugar Creek Stage surrounding initiation of the SG173 lease, as recorded by CDWR gage at RM 1.6 (CDWR 2016b).

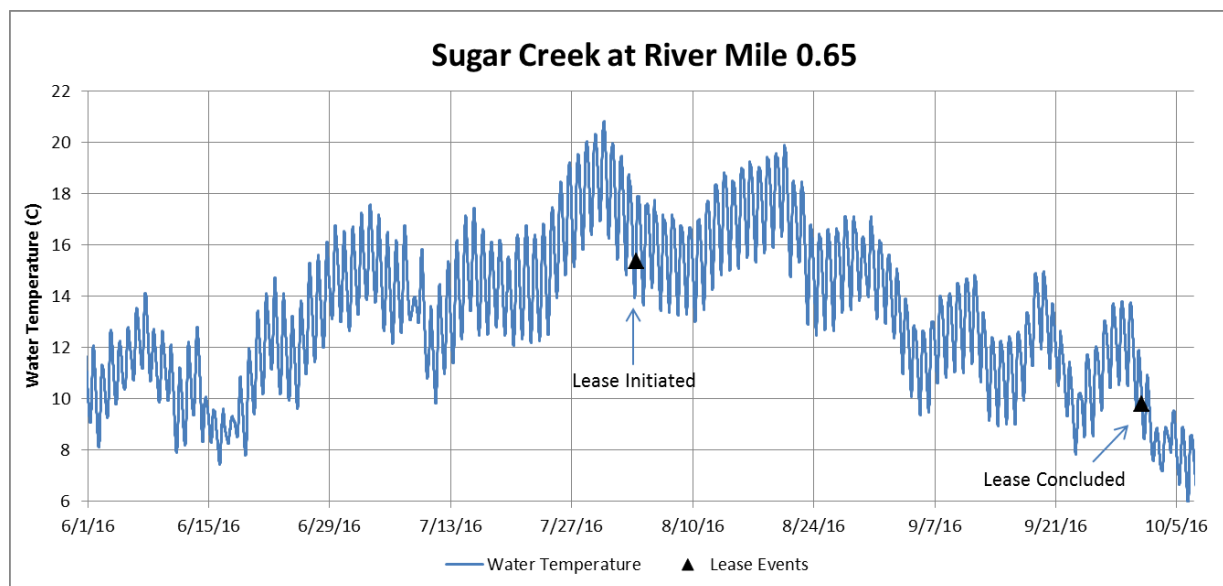
A water temperature device was not deployed on Sugar Creek below SG173 prior to initiation of a water lease because access to the site could not be coordinated. However, the Siskiyou RCD maintains a water temperature trend monitoring site in a shaded riffle at river mile 0.65 (Map 4), which is representative of conditions on the tributary (Figure 16). Because this site is located several miles downstream from the point-of-diversion, the dataset cannot be used to determine if leased water impacted the temperature regime of Sugar Creek, but it is clear that the transaction at SG173 occurred on the downward limb from summer peak temperatures.

Figure 16. Sugar Creek water temperatures during the 2016 irrigation season.
