# Monitoring Report - 2008

## Scott River Water Trust

Prepared by Erich Yokel

For the Department of Water Resources  
Division of Planning and Local Assistance  
Integrated Regional Water Management  
Agreement #4600007711

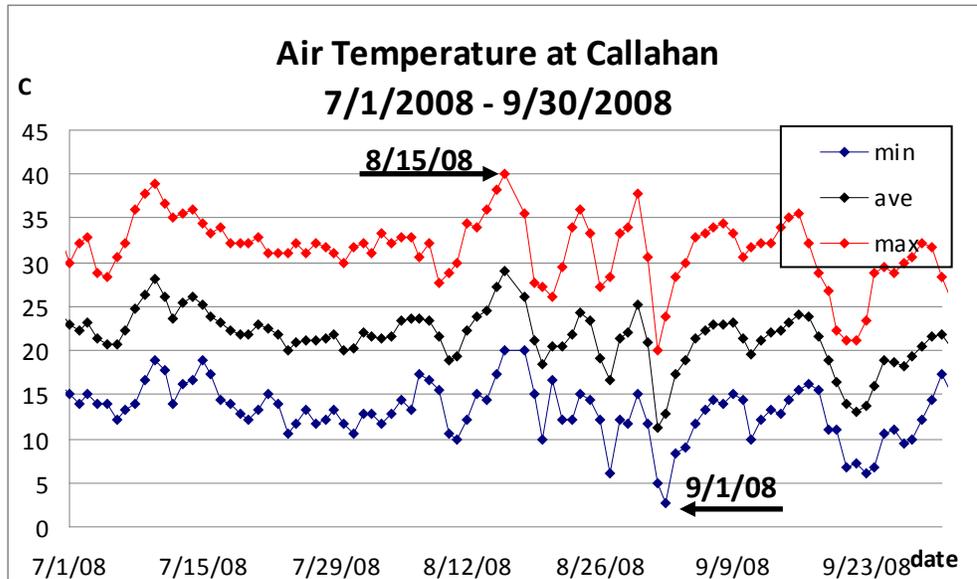
Graph 1 – Air temperature at U.S. Forest Service Station in Callahan – data retrieved from cdec.water.ca.gov on 1/12/2009.

The hourly air temperature was recorded at the U.S. Forest Service Station in Callahan in the southern end of the Scott Valley (Graph 1). Maximum daily ( $40.0^{\circ}\text{C}$ ) and average ( $29.0^{\circ}$ ) air temperatures were observed on 8/15/08 with a minimum of  $2.9^{\circ}\text{C}$  observed on 9/1/08. The majority of documented peak water temperatures correlated with the observed peak in air temperature on August 15<sup>th</sup>.

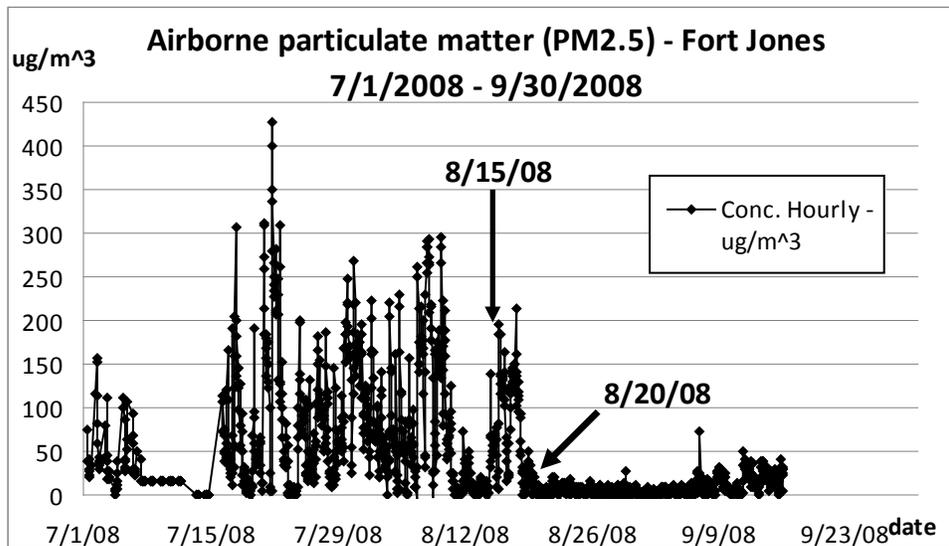
Graph 2 – Airborne particulate matter at Fort Jones

A series of forest fires were ignited in the vicinity of the Scott Valley during a lightning storm on June 22, 2008. These fires created significant amounts of smoke over the Scott Valley during July and early August. The hourly concentration of airborne particulate matter smaller than 2.5  $\mu\text{g}$  (PM 2.5) was recorded at a station in Fort Jones (Unit 92) during the period of forest fires in the near vicinity of Scott Valley. Data was retrieved from the Interagency Real Time Smoke Monitoring Website ([www.airsis.com](http://www.airsis.com)) on 5/21/2009 and is displayed (Graph 2) to aid the interpretation of the factors affecting air and water temperature in the Scott Valley. High amounts of smoke were present in the Scott Valley from 7/16/2008 to 8/10/2008. A short period of low levels of smoke from 8/10/2008 to 8/14/2008 was interrupted by increased smoke on 8/15/2008 until 8/20/2009 at which point the smoke levels decreased dramatically.

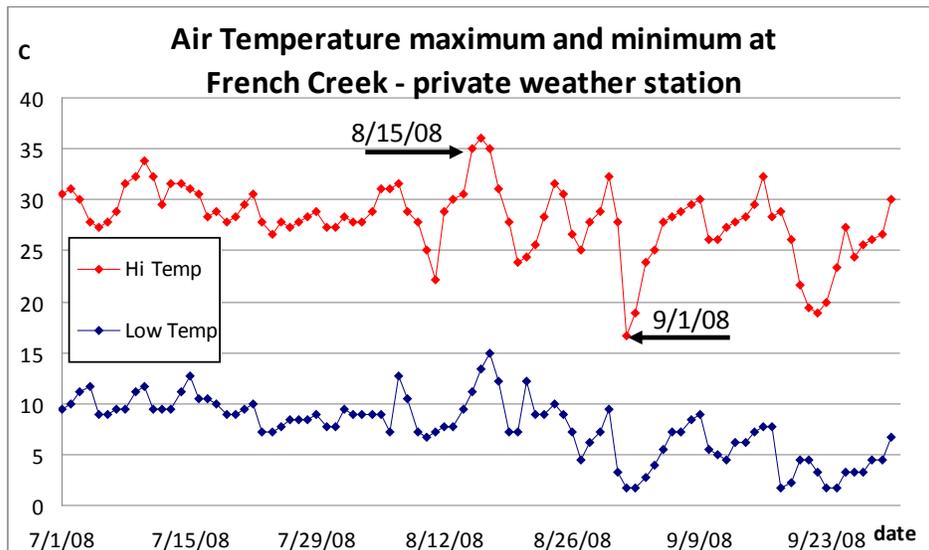
Graph 3 – Daily air temperature minimum and maximum at a private weather station in French Creek

Daily air temperature minimums and maximums were recorded at a private weather station in the French Creek watershed above the confluence with the North Fork French Creek (Elevation – 3,000 ft.) - Graph 3. The maximum air temperature at this location was 36.1° C observed on 8/16/2008.

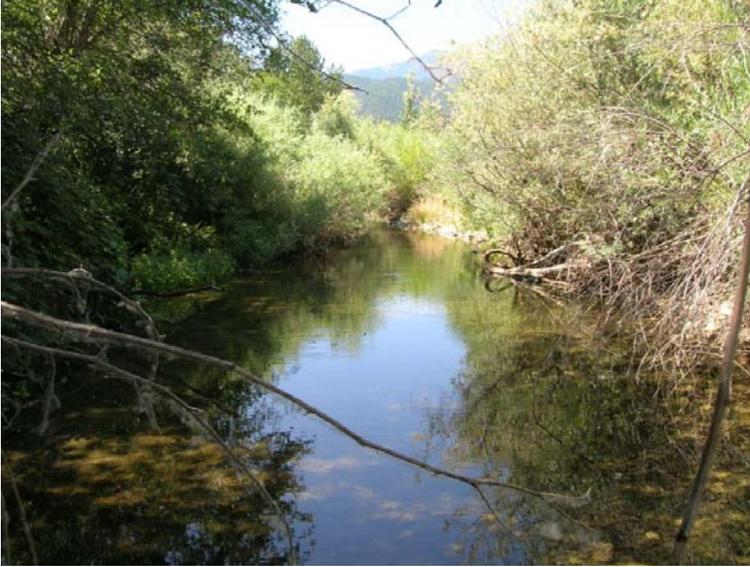
Picture 1 – Representative habitat on lower French Creek with deep low velocity water and fish cover and shade from riparian vegetation.

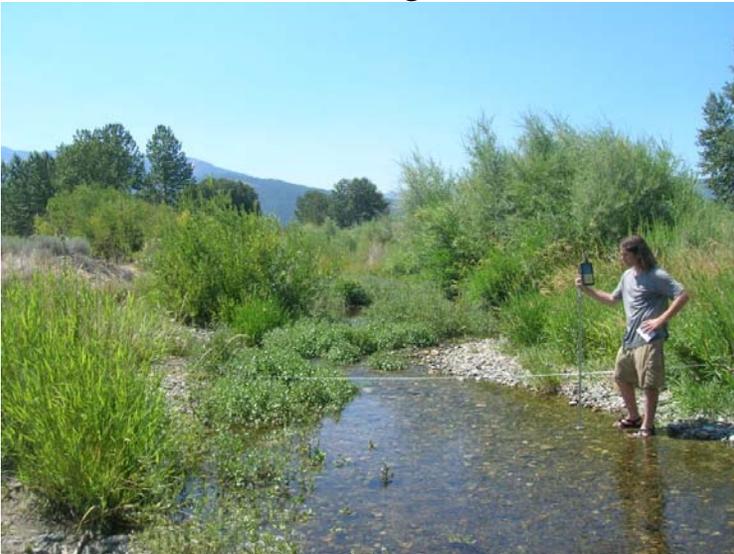
Picture 2 – Performing a discharge measurement with a current meter in lower French Cr. below Diversion #48

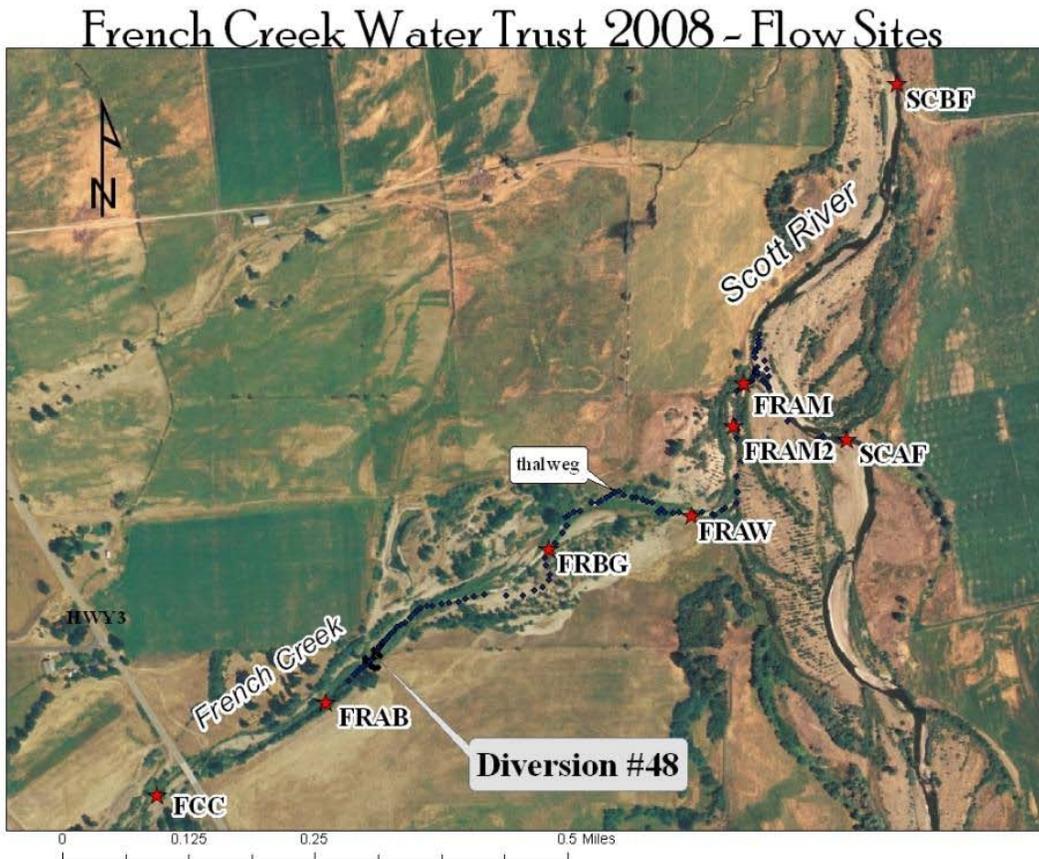
Map 1 – Flow locations monitored in Lower French Creek and Scott River – 2008

The discharge data shows an increase of 0.2 cfs above Div. #48 on July 11<sup>th</sup> in comparison to July 9<sup>th</sup>. The first flow transect shows an increase of 0.9 cfs over the period of these two days – attributable to the 0.2 cfs increase plus the 0.7 cfs increase from the forbearance of the instream water right. This gain in instream flow is not observed at downstream locations until the last transect in French Creek above the confluence with the Scott River (FRAM). A 0.4 cfs increase is observed at this location. The instream flow of the Scott River above and below the confluence of French Creek was also measured during the monitoring effort. A decrease of 4.2 cfs was observed at the location above the confluence of French Creek from July 9<sup>th</sup> to July 11<sup>th</sup> (before and after forbearance). In the same time period a decrease of 3.2 cfs was observed at the location below the confluence of French Creek. The 1 cfs increase in the discharge difference in the Scott River below and above French Creek is potentially partially attributable to the 0.7 cfs increase in French Creek flows due to the forbearance agreement.

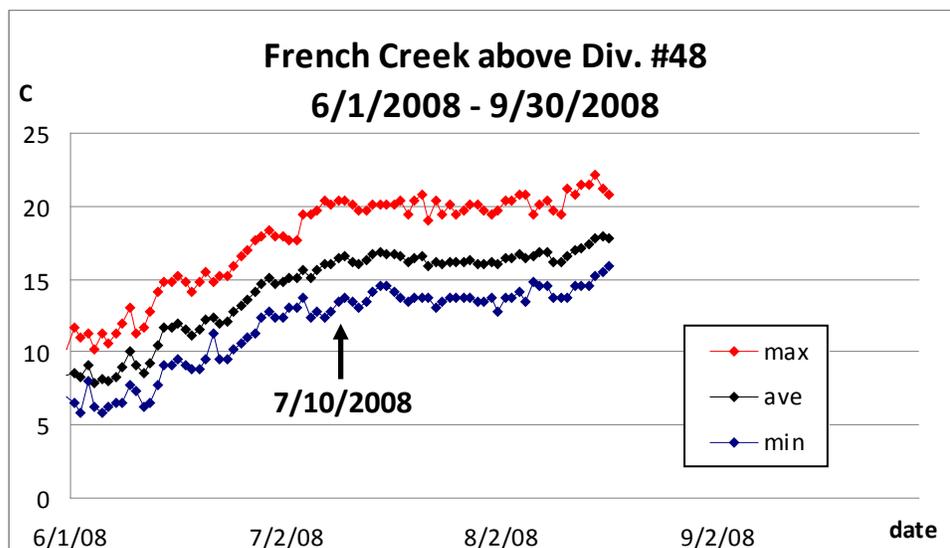
Graph 4 – French Creek above Div. #48 – riffle habitat. Device failed on 8/18/2008.

French Creek approached peak water temperatures associated with low flow through the month of June (Graph 4). The lease of 0.7 cfs of water at Div. #48 occurred at the beginning of the period of peak water temperatures.

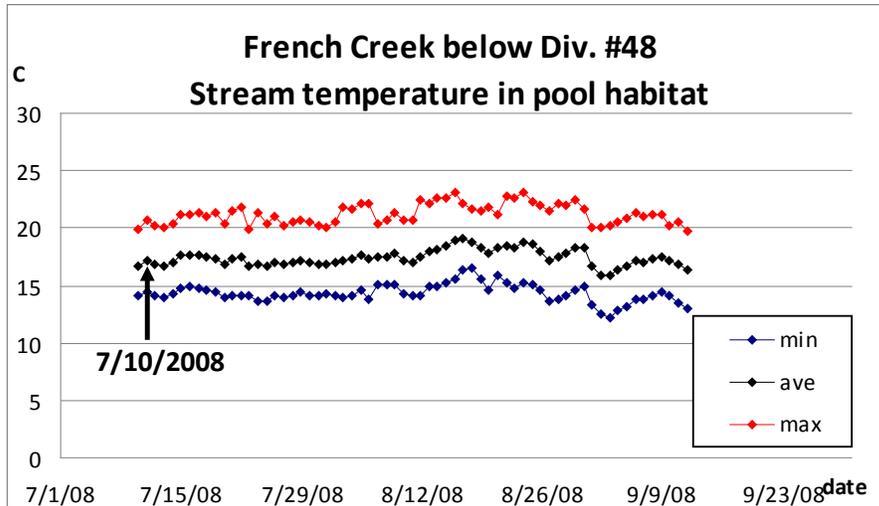
Graph 5 – French Creek below Div. #48 – pool habitat. Maximum MWAT = 18.5°, maximum MWMT = 22.4°. Maximum periodic temperature observed is 23.1° on 8/23/2008 at 16:30.

Water temperature in the pool habitat downstream of Div. #48 was mostly within the 3° C - 20° C (37 – 68° F) range that is “appropriate” for juvenile coho salmon (Hardy and Addley, 2001). The water temperature exceeded the 20° C threshold for several hours during the afternoon of most days in late July and August but juvenile salmon were observed rearing in the monitored pool and adjacent habitats.

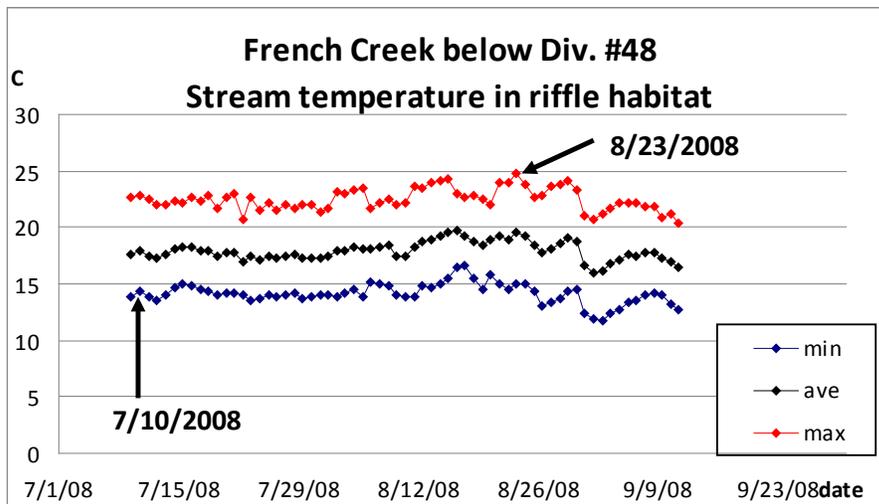
Graph 6 - French Creek below Div. #48 – riffle habitat. Maximum MWAT = 19.2°, maximum MWMT = 23.7°. Maximum periodic temperature observed is 24.8° on 8/23/2008 at 17:30

The maximum water temperatures recorded in the riffle were higher than those recorded in the pool. It is hypothesized that the riffle's wide shallow water and large surface area exposed to direct solar radiation causes increased peak water temperatures.

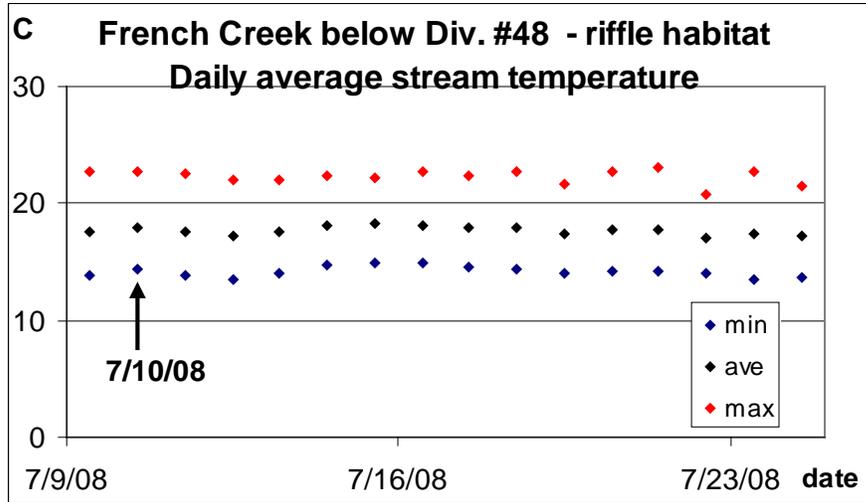
.Graph 7 – Daily average, minimum and maximum in the riffle habitat below Div. #48

Inspection of the water temperature in the riffle below Div. #48 in the immediate period before and after the lease shows no increase in stream temperature at this location (Graph 7). A minor decrease in water temperature with a slight decrease in daily fluctuation (e.g., difference in min and max temperature) is observed but it is difficult to attribute this change in temperature regime to the project or environmental conditions.

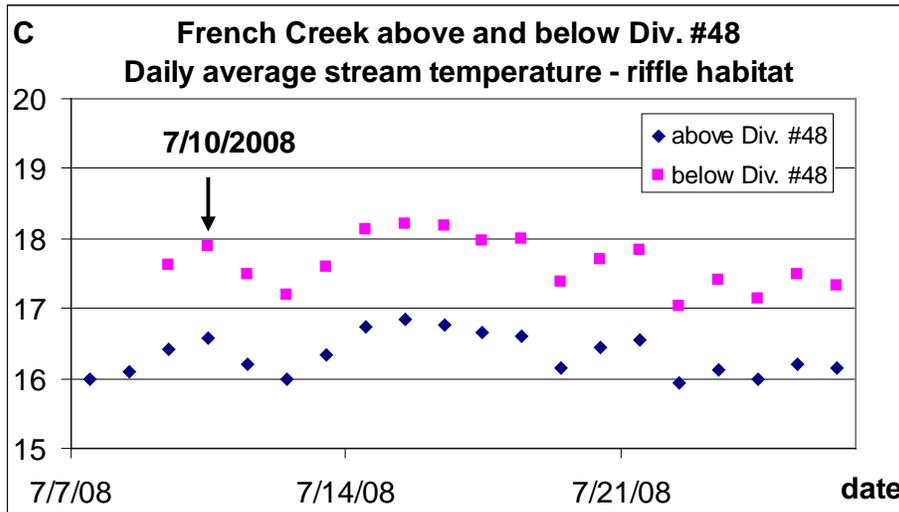
Graph 8 – Water temperatures in riffle habitat above and below Div. #48

The slight decrease in the average water temperatures below Div. #48 (less than 0.5° C) was observed in the riffle habitat above the point of diversion (Graph 8). It is hypothesized that the majority of changes in the thermal regime around the time of the transaction are attributable to changes in the environmental condition and the effect of the

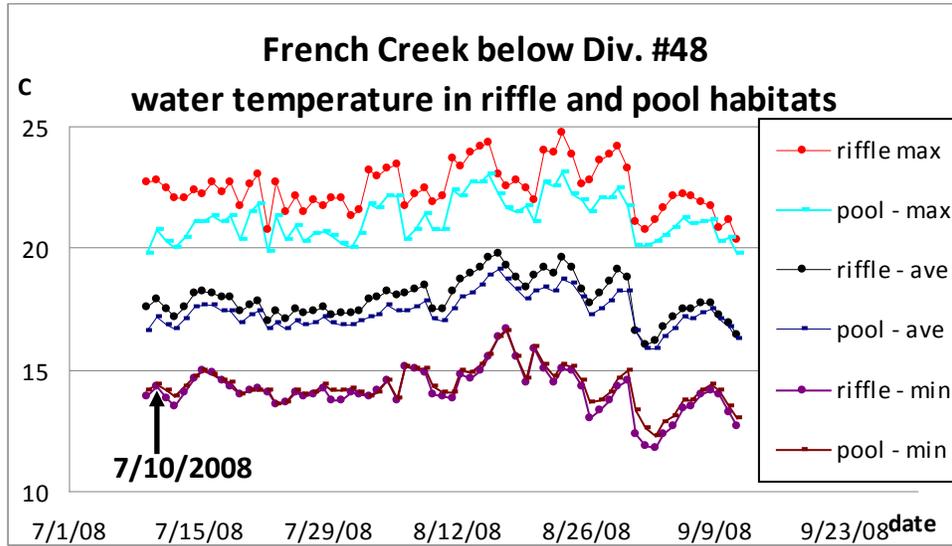
Graph 8 – Comparison of temperatures in pool and riffle habitat below Div #48 -

A comparison of the temperature regimes for the three continuous temperature monitoring locations shows a slight increase in temperature from the above Div. #48 site to the below pool site and a further increase in stream temperature at the downstream riffle/shallow glide habitat (Graph 8). A significant amount of the instream discharge was observed to be lost to the fine substrate of the streambed in the riffle habitat and reemerge in downstream locations. These observations led to the performance of periodic temperature surveys in the lower French reach to document local water temperatures in different habitats (Map 2).

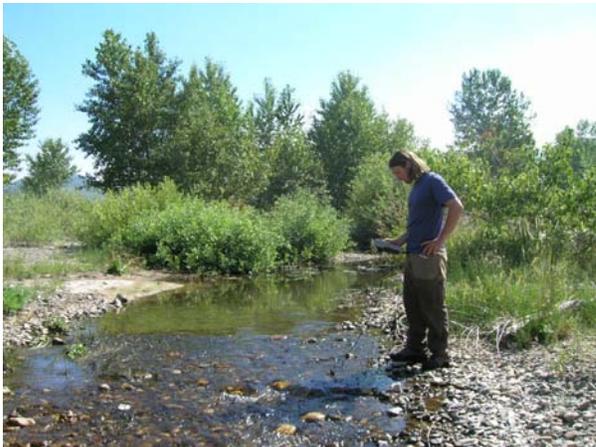
Picture 3 – Technician recording periodic temperature in a riffle in lower French Creek.

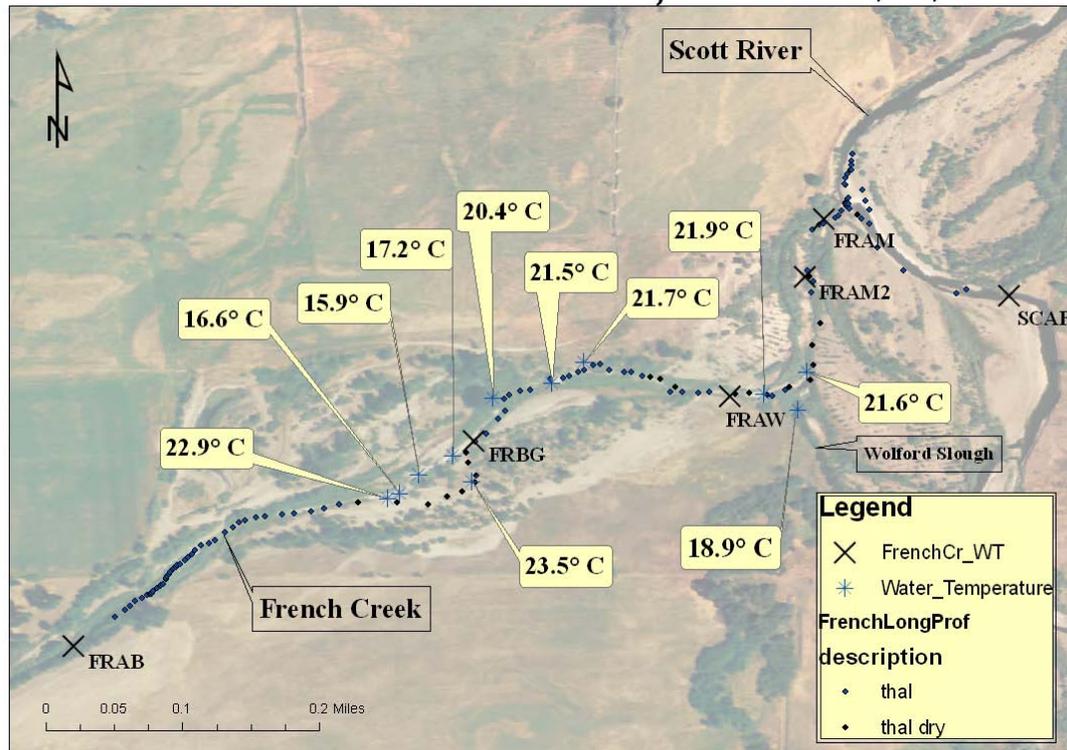
Map 2 – Periodic local water temperatures in Lower French Cr. on July 9<sup>th</sup>, 2008

Periodic surveys of select habitats were performed in lower French Creek before and after the transaction using a hand held temperature meter. Surveys were performed rapidly during the hottest period of the day (approx. 2:30pm – 4:30 pm) starting at the upstream end of the reach. These surveys showed significantly different temperatures in the different habitats of the reach. Several significantly cooler water temperatures (15.9° - 17.7° C) were observed in pools in a side channel adjacent to the monitored riffle (23.5° C). Water temperatures downstream from the riffle and side channel reach were all cooler (20.4° - 21.9° C) than the temperature recorded upstream of the glide (22.9°). If solar heating was the only process affecting water temperature one would expect a slight increase in recorded temperature as the survey effort moves downstream. It is hypothesized that a medley of groundwater – surface water interactions in this alluvial reach and a variety of levels of exposure to solar radiation is affecting the local water temperatures.

These periodic observations documented that the riffle in which continuous water temperature was monitored had the highest afternoon water temperature (23.5° C) observed throughout the reach. Exclusively monitoring the stream temperature in the first riffle below the project location would document the warmest waters and would not capture the presence of cooler temperature regimes in the deeper habitats occupied by target fish downstream.

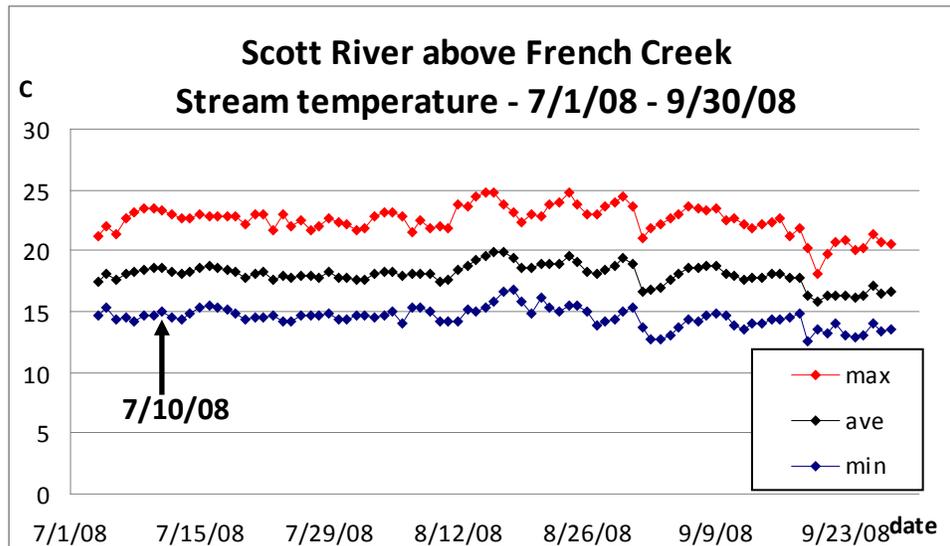
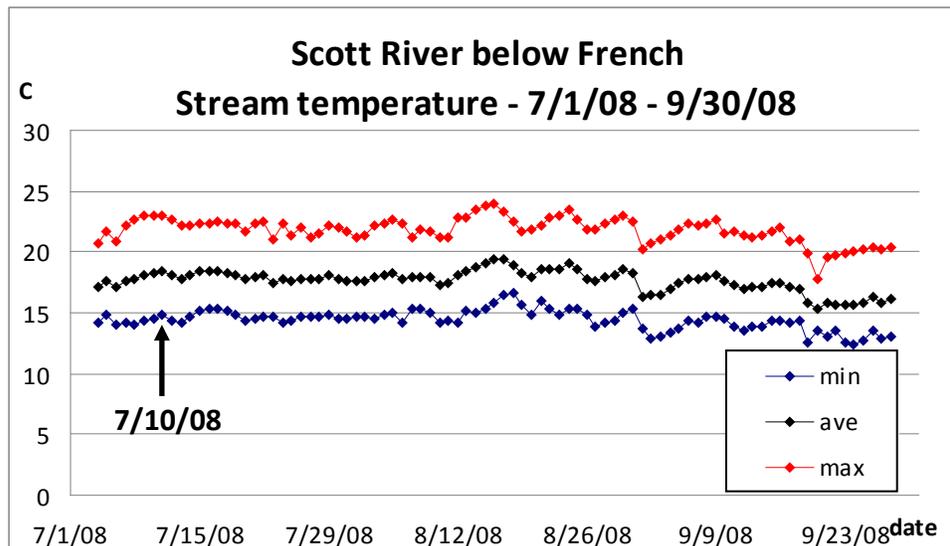
Graph 9 – Scott River above French Creek - Maximum MWAT = 19.3°, maximum MWMT = 24.1°. Maximum periodic temperature observed is 24.8° on 8/15/2008 at 15:50.

Graph 10 – Scott River below French Creek - Maximum MWAT = 18.9°, maximum MWMT = 23.3°. Maximum periodic temperature observed is 23.9° on 8/15/2008 at 16:30.

Water temperatures in riffles of the Scott River above and below the confluence with French Creek were recorded during the period of the Water Trust transaction (Graph 9 & 10). This data shows a decrease in the ambient water temperature of the Scott River downstream of French Creek in comparison to the temperature upstream of French Creek. No noticeable effect on water temperature is observed in the Scott River below French Creek after the leasing of 0.7 cfs of water on July 11<sup>th</sup>.

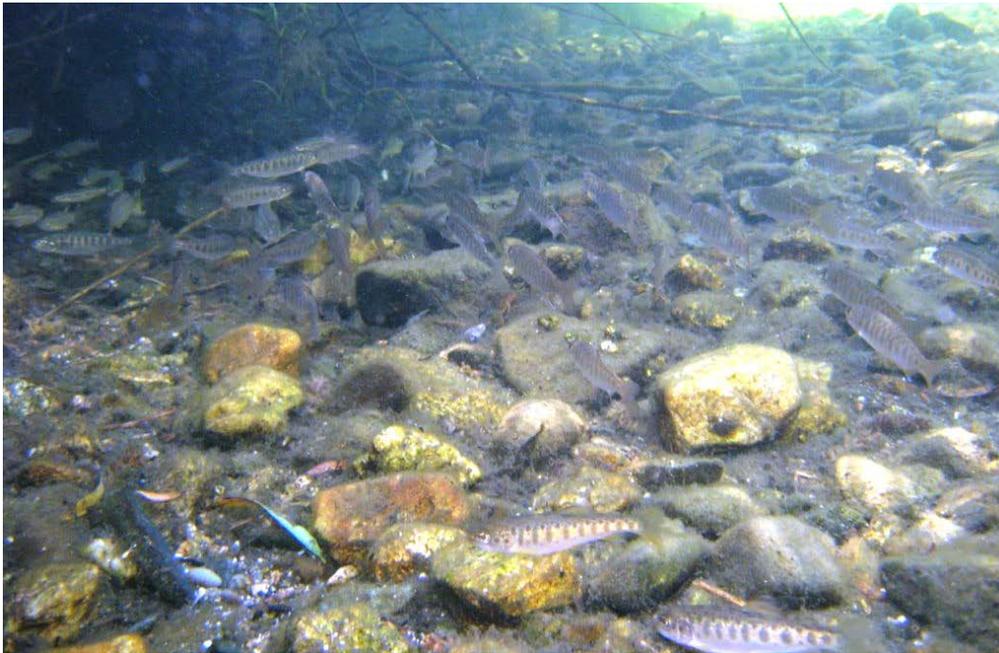
Picture 4 – juvenile coho and trout using instream cover in lower French Creek

Juvenile coho were often found in pool habitats and deeper glide habitats that offered cooler local water temperatures combined with over hanging and/or instream fish cover elements. Coho and Chinook salmon were observed in a pool in a sidechannel offering extensive cover from willow and water temperatures of 18.8° C. This contrasts with an adjacent pool of equivalent size that lacked the extensive cover and had water temperatures of 23.0° C in which only rainbow trout were observed. These two waters mixed at a pool with willow cover and large numbers of coho salmon with temperatures of 21.3° C observed at the pool's tail out. Coho and Chinook salmon were found in multiple habitats below these locations and were usually associated with small pockets of percolating water that was considerably cooler than the well mixed waters of the stream's riffles. A pool directly above the mouth of French Creek had a temperature of 16.4° C on its bottom and cold water and juvenile salmon were observed in the Scott River at the confluence of French Creek. Juvenile salmon and cooler water was documented in a scour hole in the Scott River below the confluence with French Creek. A similar scour

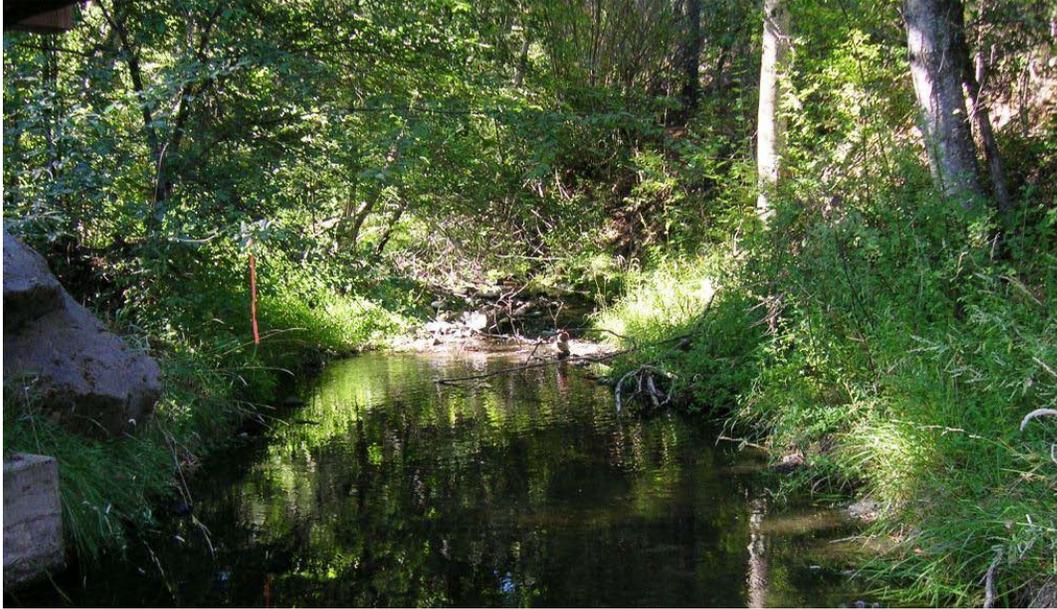
Picture 5 – Pool below diversion #33 – Miners Creek

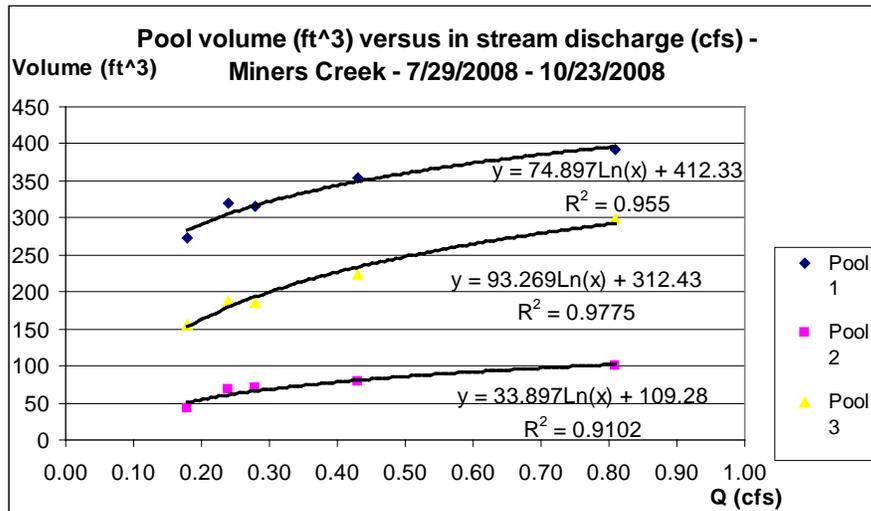
An increase in pool volume and in stream flow was observed after the transactions of 7/29/2008 and 8/21/2008. All pools gained volume between the initial pre treatment measurement of 7/29/2008 and the post treatment measurement performed on 8/28/2008. An increase over initial volume of 30% was observed for Pool 1, an increase of 81% was observed for Pool 2, and an increase of 45% was observed for Pool 3. The combined volume of the three pools was increased to 656 cubic feet on 8/28/2008 from 470 cubic feet on 7/29/2008 – an increase of 40%. The final pool volume and flow measurement was performed on 10/23/2008 - showing a combined increase of approximately 70% of the initial pre-treatment pool volume. Discharge of Miners Creek is still approximately 1 cfs at this time.

Graph 11 – Pool volume (cubic feet) versus in stream discharge (cfs) for three pools in Miners Creek below Div. #33.

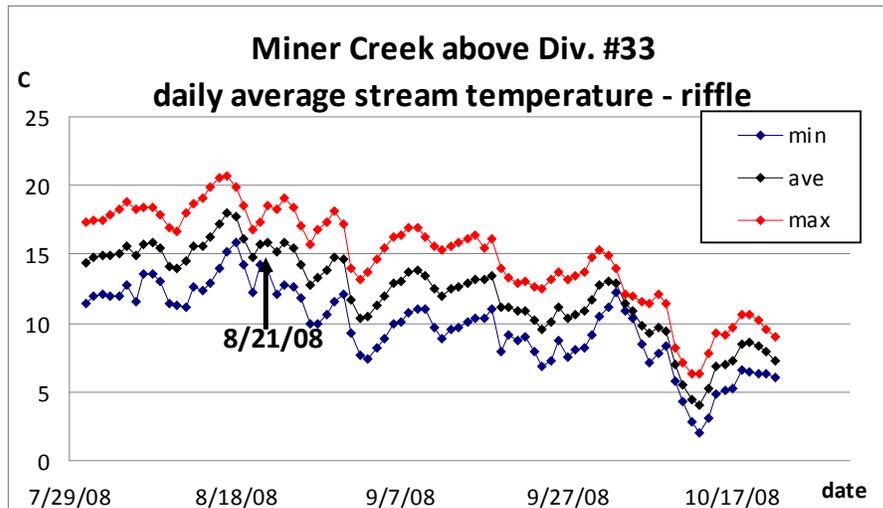
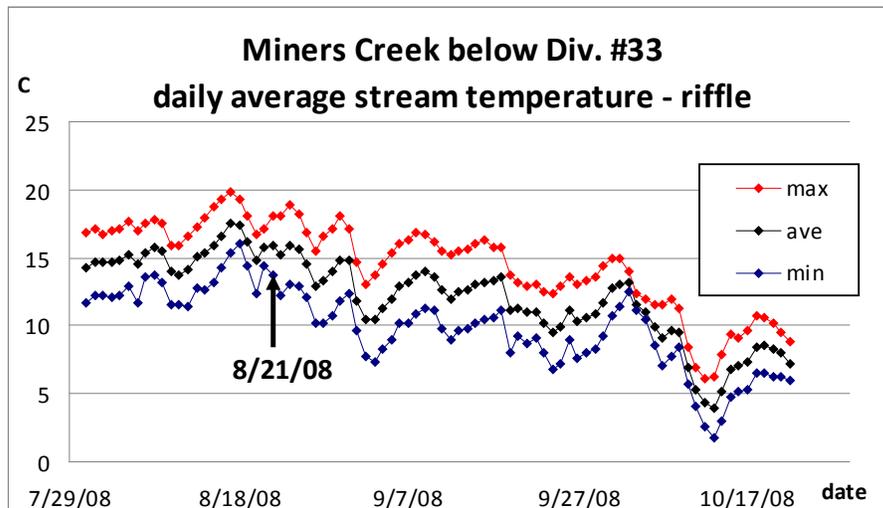
Stream temperature was monitored in riffle habitats above and below Div. #33 from 7/29/2008 – 10/24/2008 (Graph 12 & 13). The temperature monitoring devices were not placed in stream for the 24 hour period before the first transaction of .2 cfs on 7/29/2008 but were in place during the transfer of an additional .3 cfs to Miners Creek on 8/21/2008.

Graph 12 – Miners Creek above Div. #33 - Maximum MWAT = 16.6°, maximum MWMT = 19.6°. Max periodic temperature observed is 20.7° on 8/16/2008 at 17:24.

Graph 13 – Miners Cr. below Div. #33 - Maximum MWAT = 16.3°, maximum MWMT = 18.6°. Max periodic temperature observed is 19.8° on 8/16/2008 at 17:40.

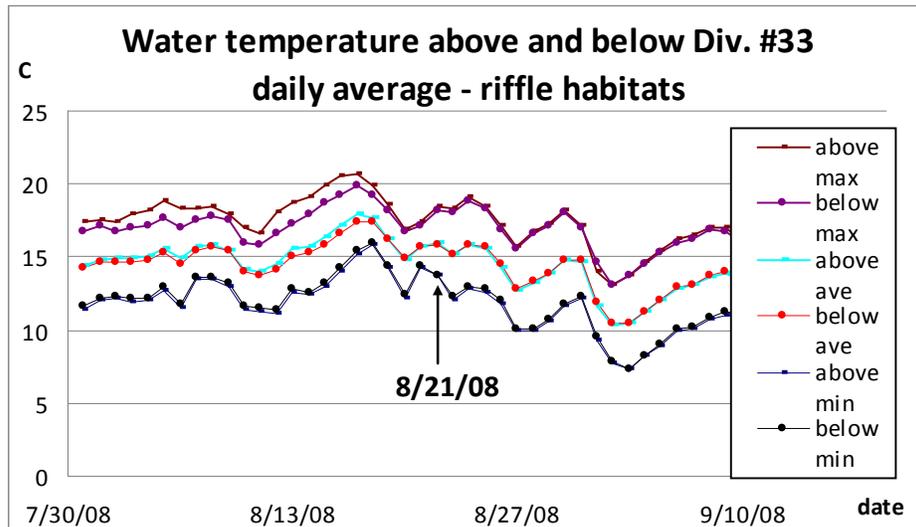
Graph 14 – Stream temperature above and below Div. #33 – Miners Creek

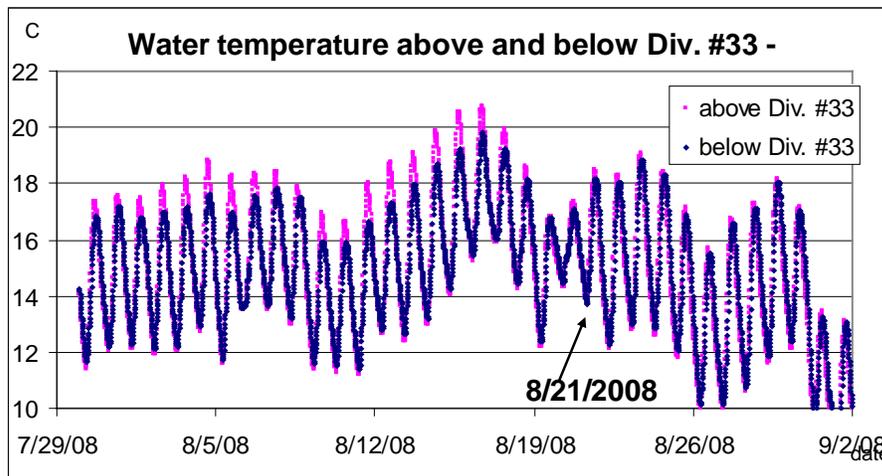
Graph 15 – Continuous stream temperature above and below Div. #33 – Miners Creek

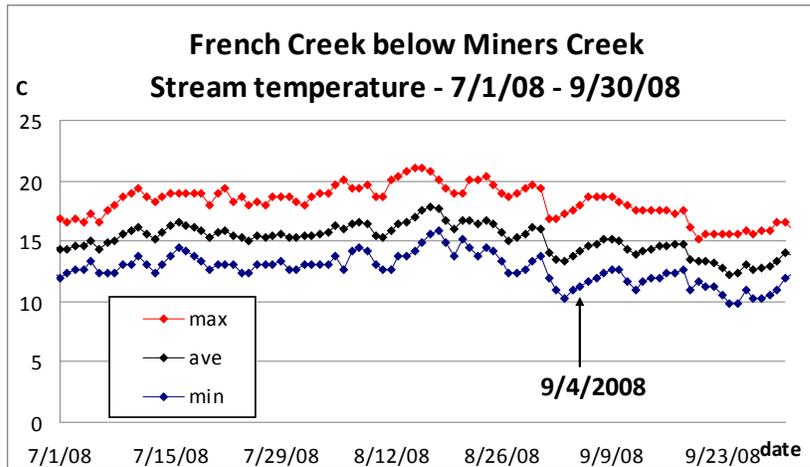
A temperature device was operating in French Creek below the confluence with Miners Creek (Graph 16). Suitable temperatures for rearing salmonids were documented in this reach of French Creek that was affected by the water leased in Miners Creek.

Graph 16 – French Creek below Miners Creek - Maximum MWAT = 17.1°, maximum MWMT = 20.6°. Max periodic temperature observed is 21.1° on 8/14/2008 at 15:32.

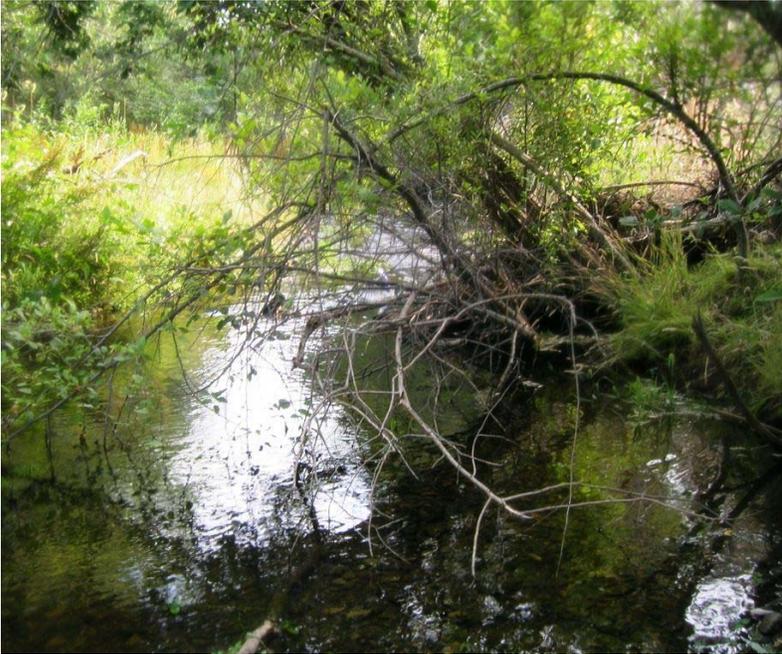
Picture 6 – Pool with fish cover from root mass and overhanging riparian canopy

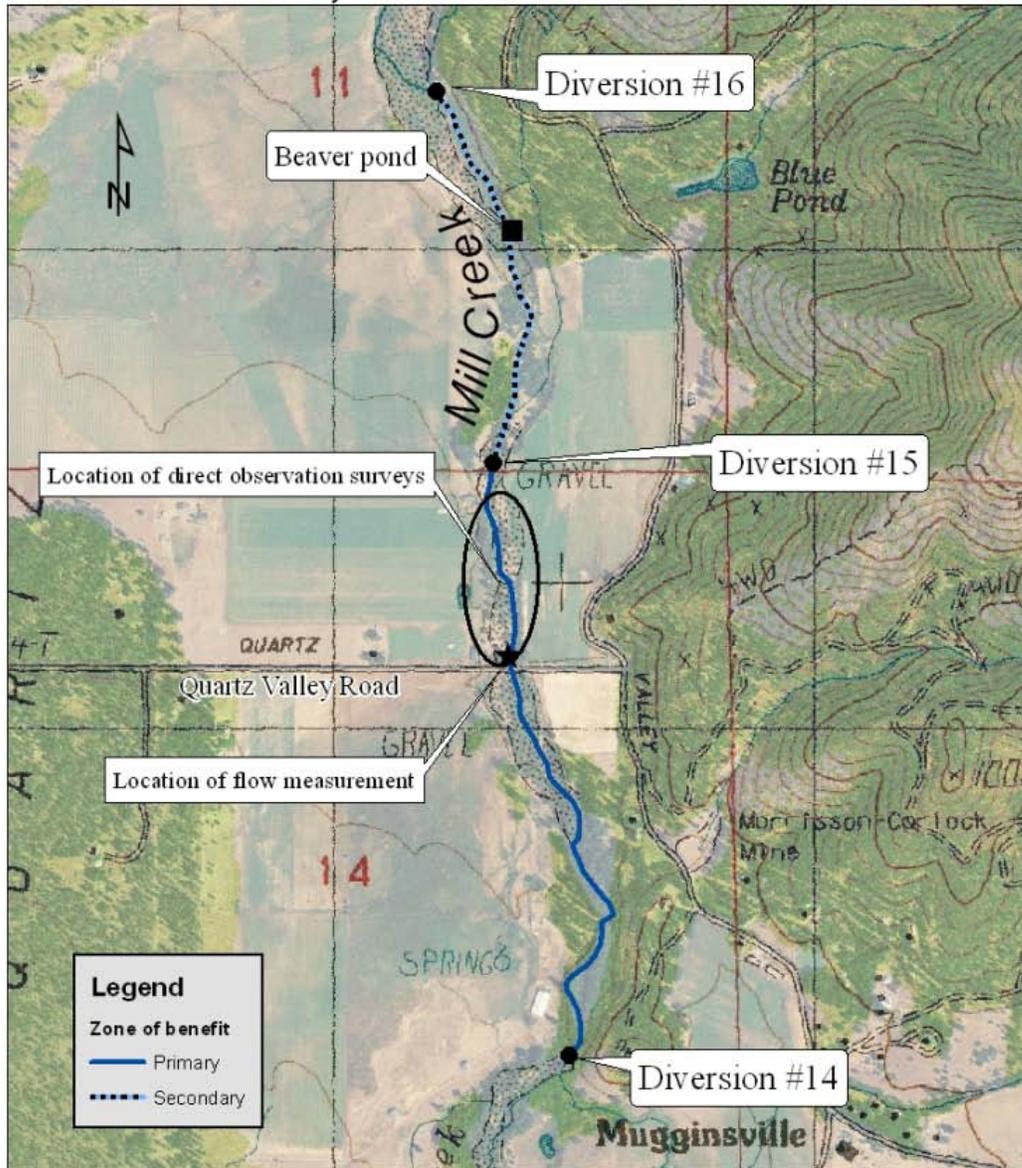
Map 3 – Location of monitoring sites and potential zone of benefit in Mill Creek

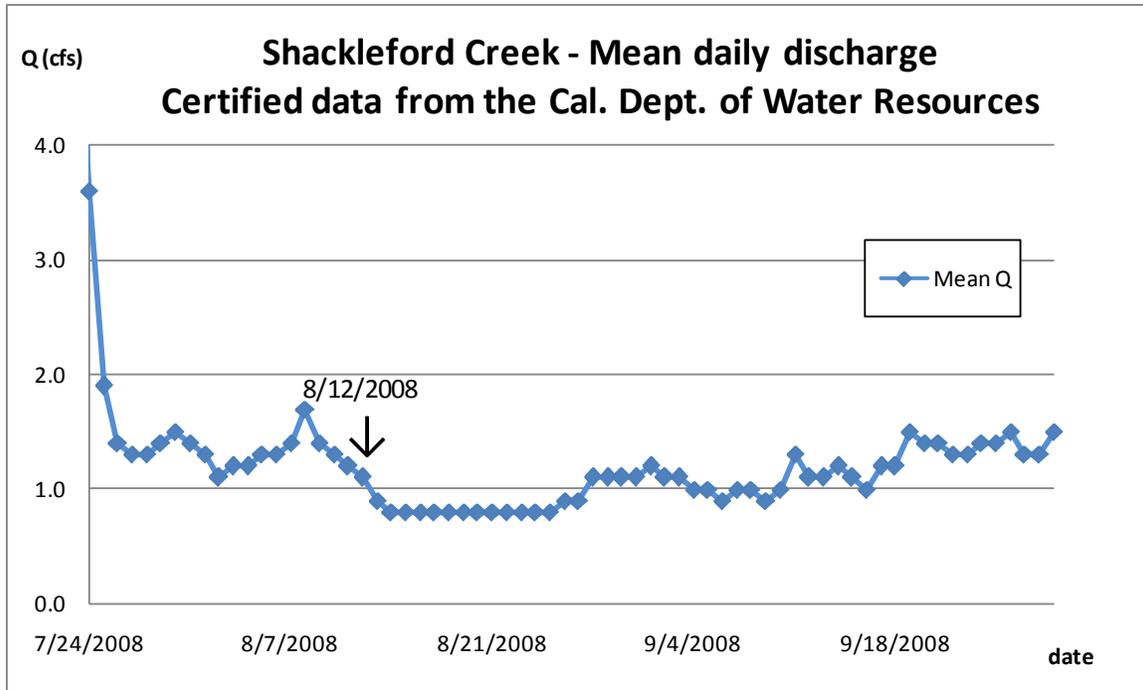
Graph 16.1 – Mean daily discharge in lower Shackleford Creek – data courtesy of DWR

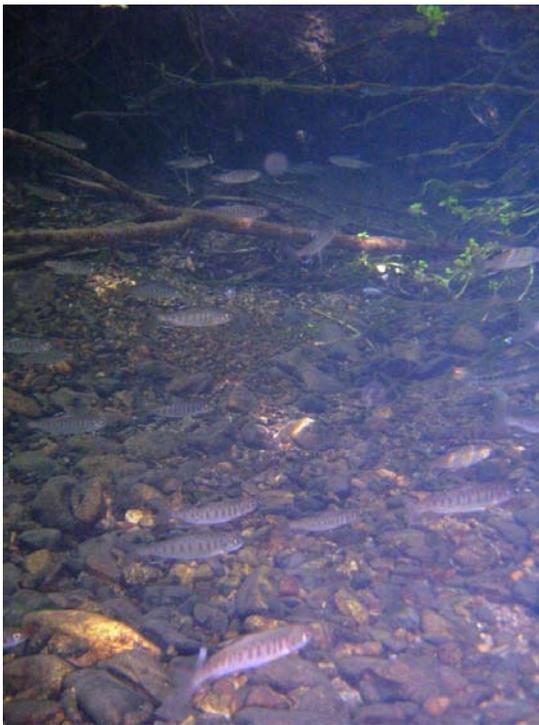
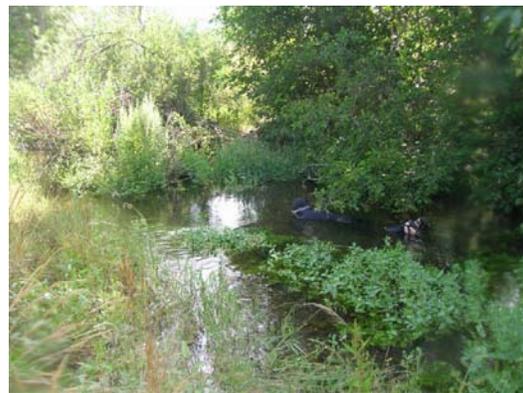
Picture 7 & 8 - Juvenile coho salmon and rainbow trout in Mill Creek below Diversion #14 (left) and direct observation survey in glide with aquatic vegetation and over stream alders (right)

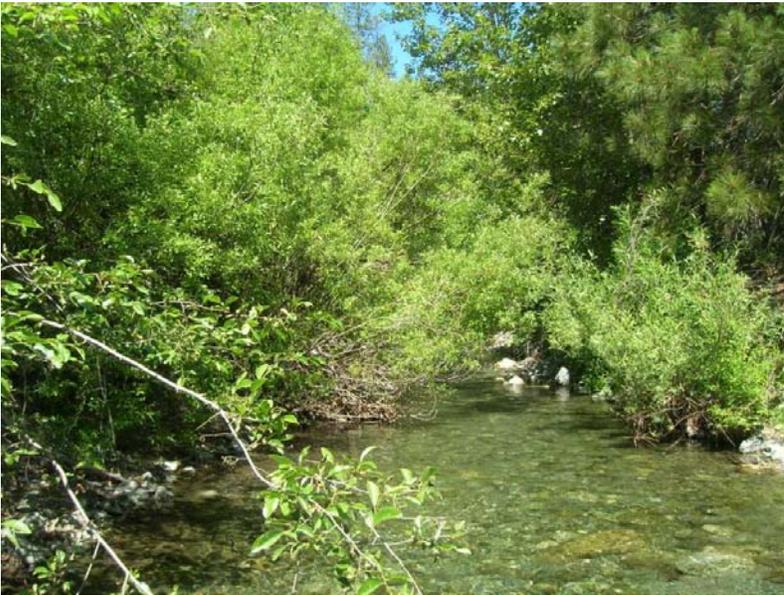
Picture 9 – Patterson Creek below Diversion #390

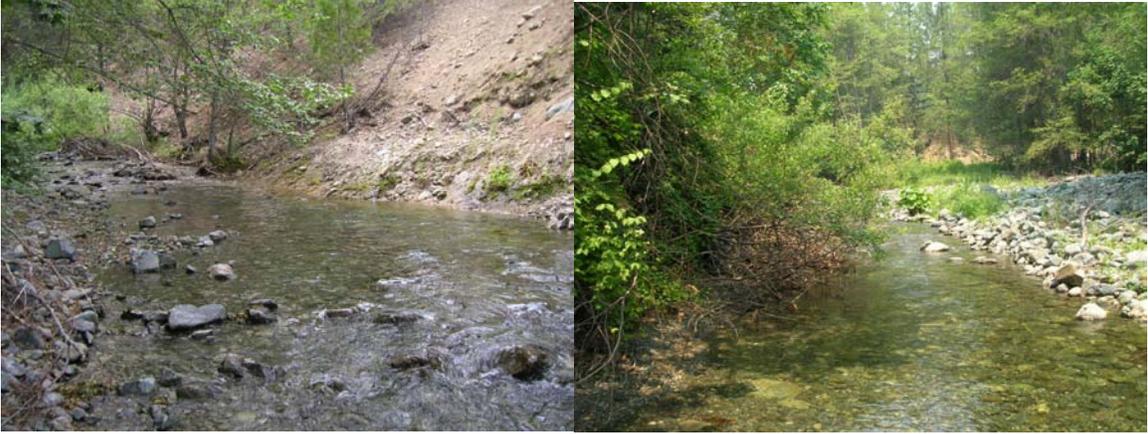
Picture 10 & 11 - Control pool (left) and Glide\_1 (right) in Patterson Creek

Four different habitat units were selected for pool volume measurements before and after the transaction of 1.0 cfs of water at Diversion #390 in Patterson Creek. A “Control Pool” was established above the point of diversion to document any change in pool volume that is due to a change in the environment (e.g. stream discharge) and not attributable to the actions of the Water Trust. Three habitats with observed juvenile coho were selected below the fish screen’s bypass – a glide (Glide\_1), a plunge pool (Pool\_1) and a large pool with significant fish habitat elements (Pool\_2). The transects and locations for depth measurements were established in each unit from July 1<sup>st</sup> – July 3<sup>rd</sup> before the return of water to Patterson Creek began. The discharge in Patterson Creek was measured on July 1<sup>st</sup> and July 2<sup>nd</sup> with values of 6.4 cfs and 6.6 cfs, respectively. The stream discharge was not measured on the 3<sup>rd</sup> due to time constraints and the belief that previous measurements established the pre treatment instream flow at 6.5 cfs. The pool volume measurements and instream discharge measurements were performed on the 4<sup>th</sup> of July to document environmental conditions directly after the return of the instream flow to Patterson Creek.

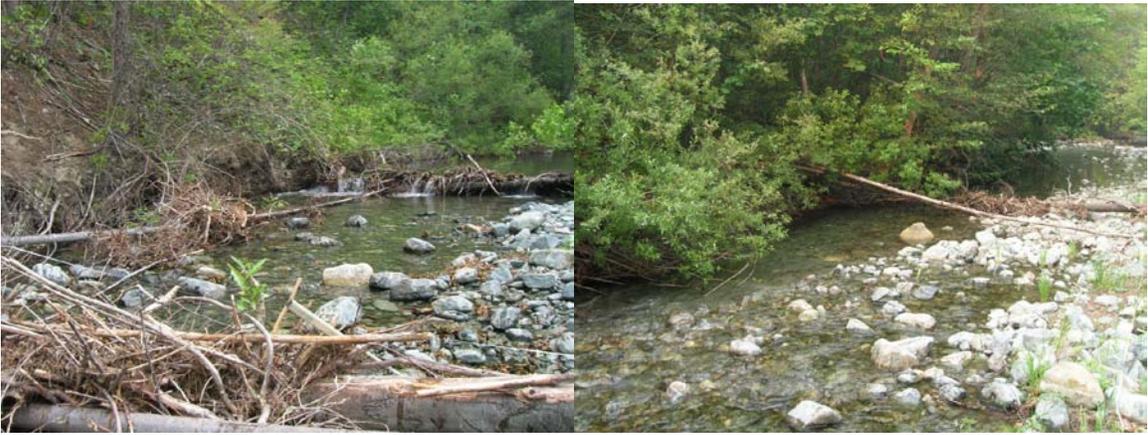
Picture 12 & 13 - Pool\_1 (left) and Pool\_2 in Patterson Creek

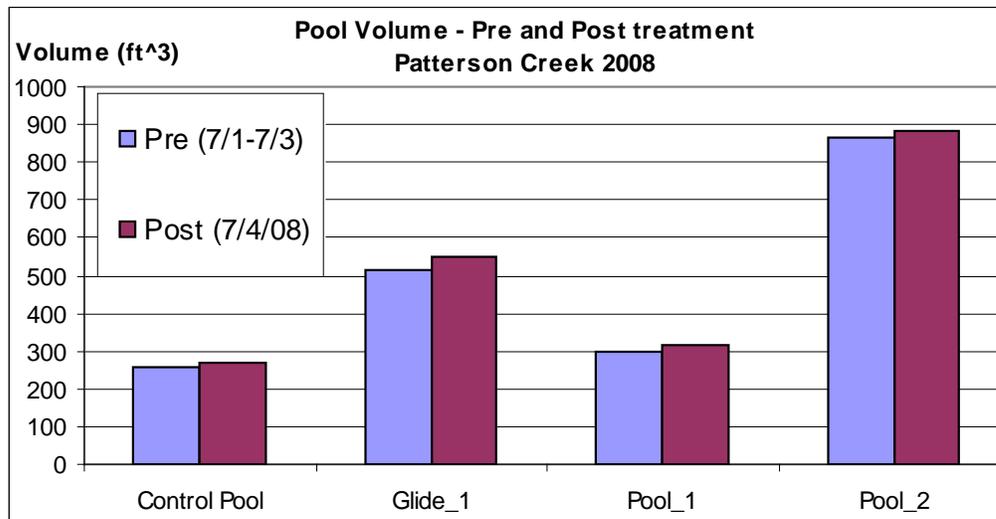
Graph 17 – Pool volume in all four habitat units before and after water is added.

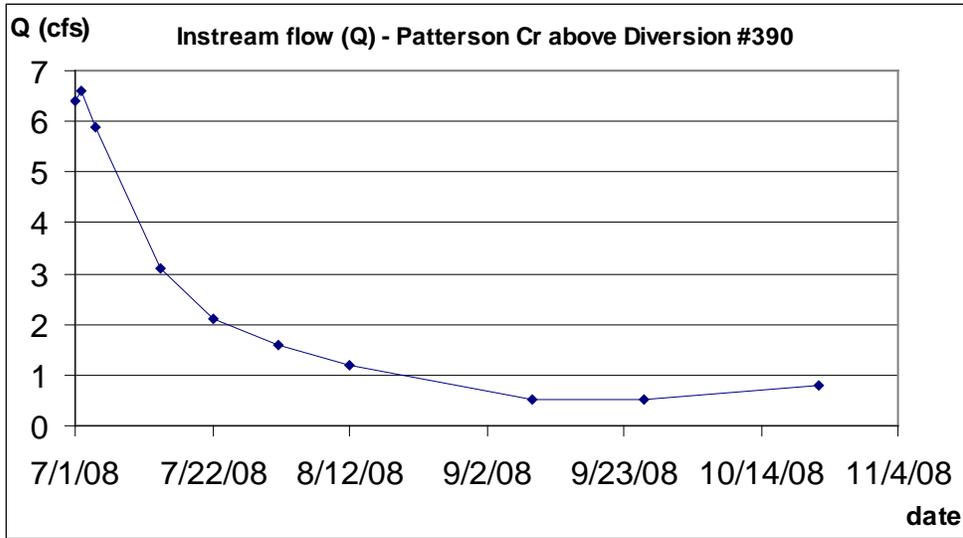
Graph 18 – Instream flow of Patterson Creek above Diversion #390

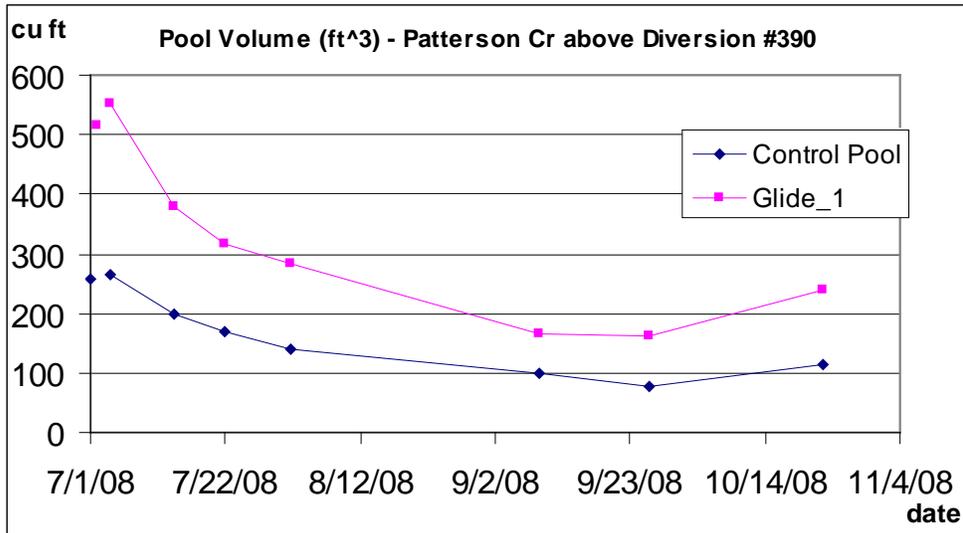
The habitat volumes of the Control Pool and Glide\_1 unit were measured several times from July through late October (Table 4). The instream flow was measured during each of these exercises. The combined pool volume below Diversion #390 before the transaction was 1680 cu ft. This combined volume was increased by 67 cu ft to a total of 1747 cu ft on the 4<sup>th</sup> of July after 1.1 cfs of water was added to the instream flow. This post treatment total pool volume was 4% greater than the pre treatment total pool volume (Graph 17). Instream flow in Patterson Creek and pool volumes decreased significantly through July with a stream discharge of less than 2 cfs documented on August 1<sup>st</sup>. Instream flows continued to decline through September and flows less than 1 cfs were documented in September and late October (Graph 18). Documented pool volumes were at there lowest level on September 26<sup>th</sup> (Graph 19).

Graph 19 – Pool volumes in control pool and glide
