# Monitoring Report - 2008

## Scott River Water Trust

Prepared by Erich Yokel

For the Department of Water Resources  
Division of Planning and Local Assistance  
Integrated Regional Water Management  
Agreement #4600007711

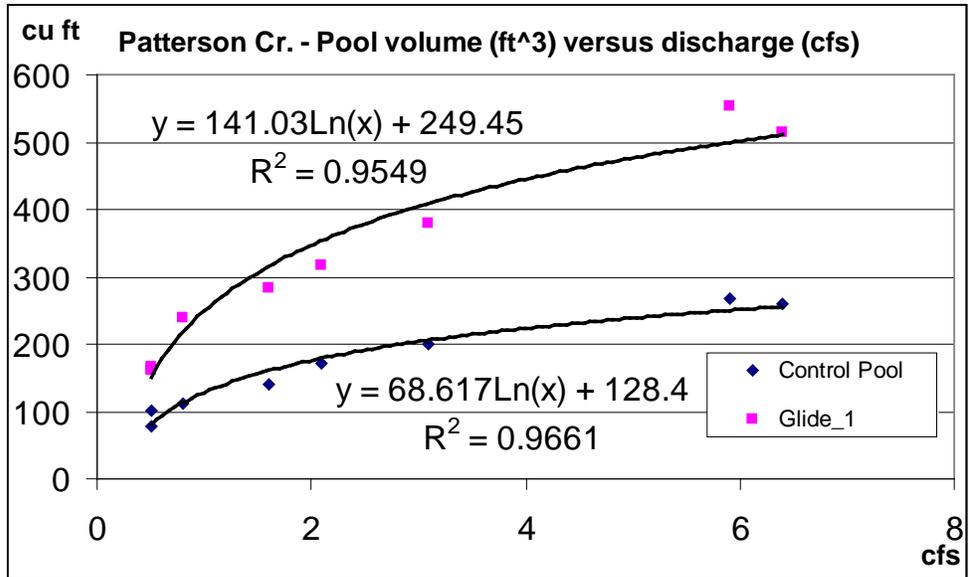
The pool volumes of the Control Pool and Glide were graphed versus the measured discharge and a logarithmic equation was generated from the trend of the data set (Graph 20). This equation could be used to determine the potential pool volume at stream discharge levels that were not monitored. The “potential” diversion volume was also calculated using the measured ratio of discharge at the fish screen inlet and in the ditch before the lease was executed (Graph 21). This exercise was performed to determine the volume of water the ditch could potentially divert from the discharge measurements performed at the fish screen inlet.

Graph 20 – Control pool and glide volume versus instream discharge

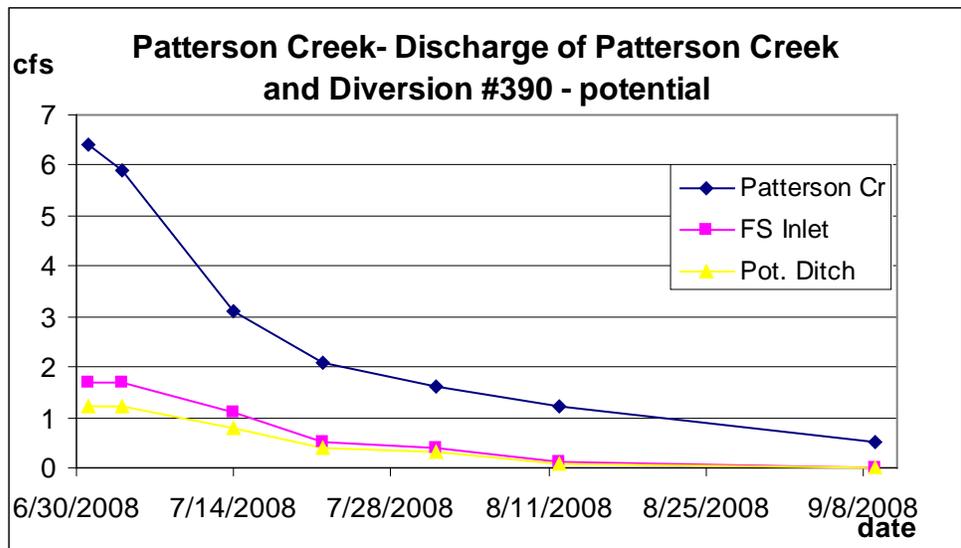
Graph 21 – Potential ditch calculation for Water Trust

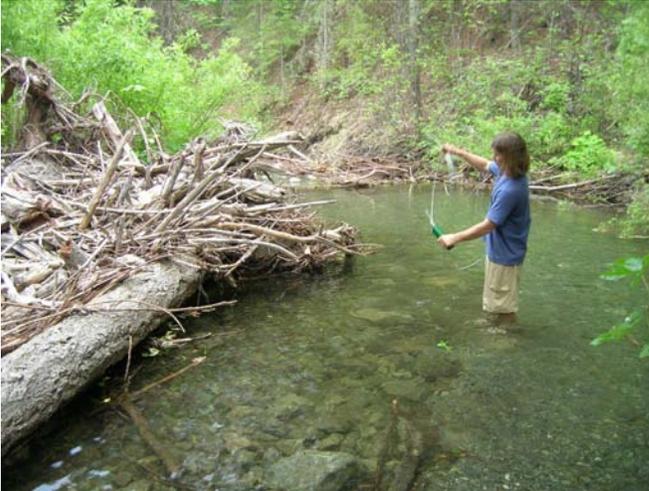
Picture 15 – The deployment of a water temperature logger in a pool occupied by coho salmon in Patterson Creek.

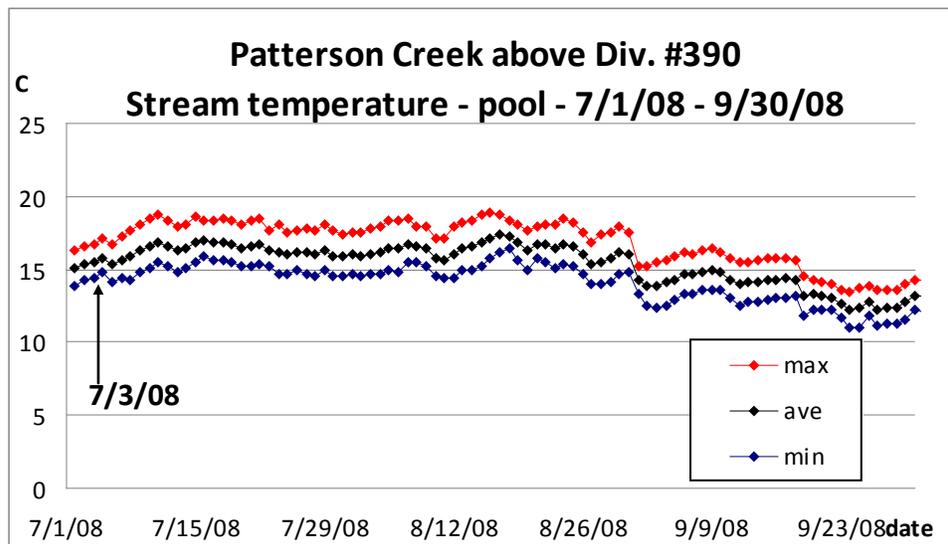
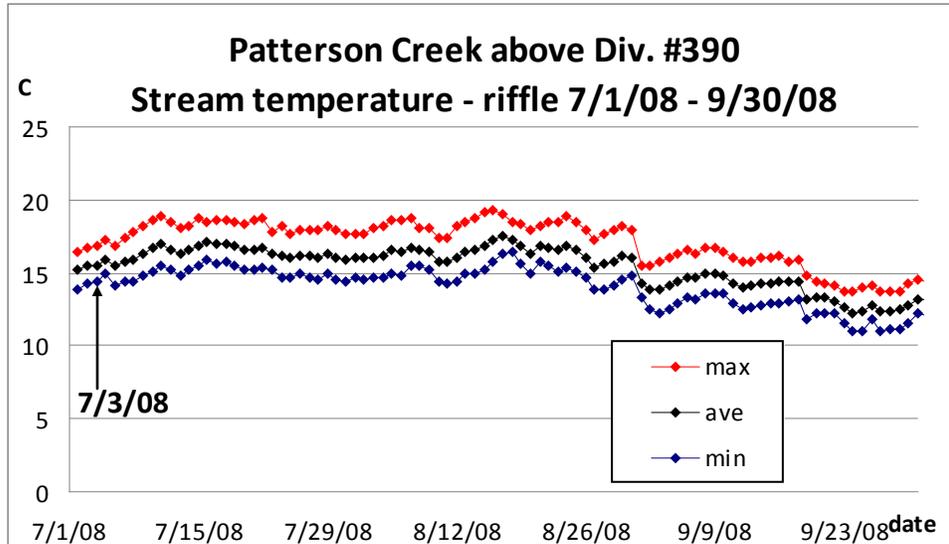
Graph 22 – Patterson Creek above Diversion #390– pool habitat - Maximum MWAT = 16.9°, maximum MWMT = 18.5°. Maximum periodic temperature observed is 18.9° on 8/15/2008 at 15:14.

Graph 23 – Patterson Creek above Diversion #390– riffle habitat - Maximum MWAT = 17.0°, maximum MWMT = 18.8°. Maximum periodic temperature observed is 19.3° on 8/15/2008 at 15:14.

The water temperature regimes documented in the riffle and pool habitat above the point of diversion were almost identical (Graph 22 and 23). A slightly higher MWAT, MWMT and maximum periodic temperature was observed in the riffle habitat in comparison to the values for these parameters observed in the pool habitat. The difference is almost insignificant and both locations offered a “suitable” temperature regime for juvenile coho with temperatures not exceeding 20° C at any time. Direct observation surveys documented coho salmon and rainbow trout utilizing the monitored pool allowing for the documentation of the temperature regime for a habitat with rearing coho.

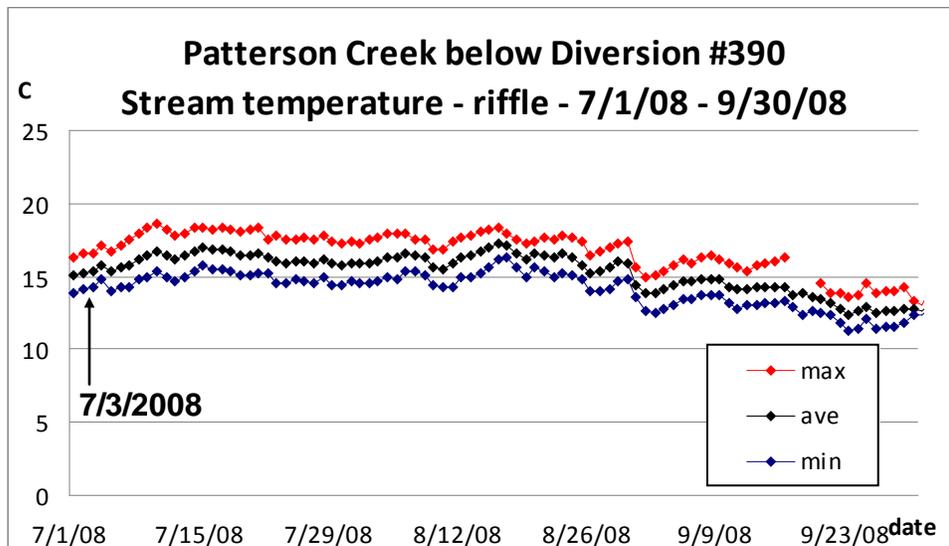
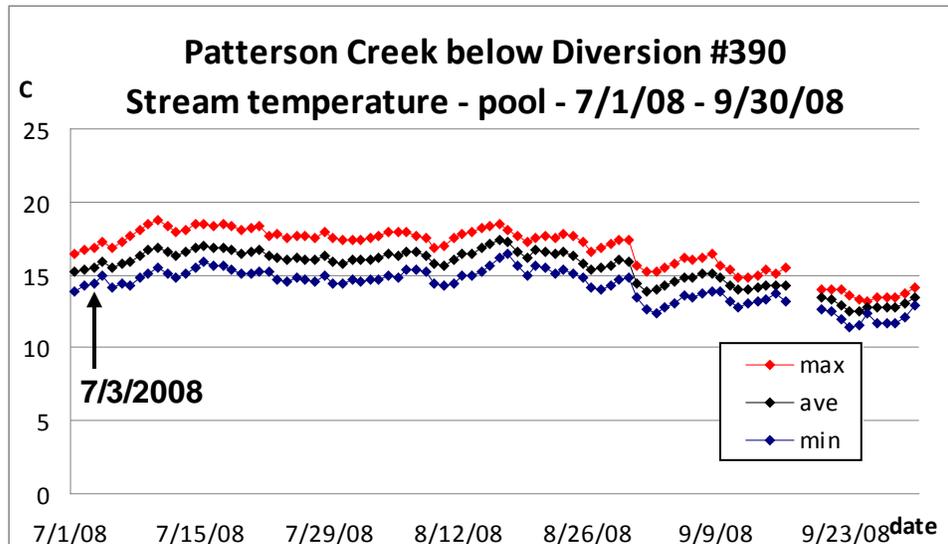
Graph 24 – Patterson Creek below Div. #390– riffle - Maximum MWAT = 16.7°, maximum MWMT = 18.3°. Maximum periodic temperature observed is 18.6° on 7/10/2008 at 14:43.

Graph 25 – Patterson Creek below Div. #390 – pool - Maximum MWAT = 16.9°, maximum MWMT = 18.4°. Maximum periodic temperature observed is 18.7° on 7/10/2008 at 14:42.

A pool and riffle habitat was continuously monitored for water temperature below the point of diversion and fish screen bypass for the period of transaction (Graph 24 & 25). The water temperature regime was almost identical in these two habitats. Juvenile coho and rainbow trout were observed in the pool habitat in large amounts during direct observation surveys.

The pool upstream from the Pool\_1 features a large rootwad associated with other coarse woody debris and a log “dam” that increases the pool’s depth and volume. This is the pool with the downstream pool temperature logger (Graph 25). There is a significant volume of complex low to no velocity water underneath the rootwad and woody debris aggregate. This area and the adjacent deep scour hole were occupied by a large number of coho (150+) with the larger coho in small niches directly under the coarse wood. Young of the year rainbow trout and one large rainbow trout (8 inches) were also observed in this pool with superb habitat.

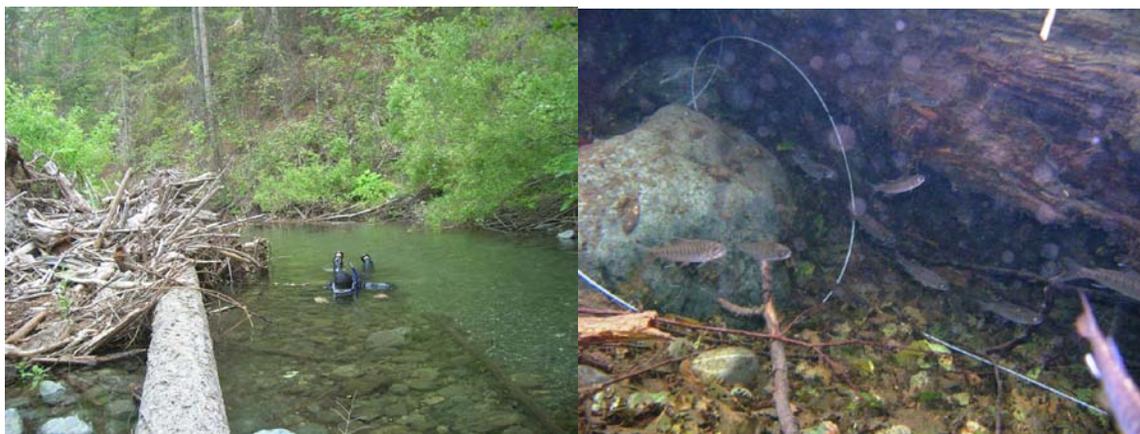
Picture 15 & 16 – direct observation survey of temperature monitoring pool below Upper Youngs point of diversion (left) and juvenile coho and trout rearing in pool (right).

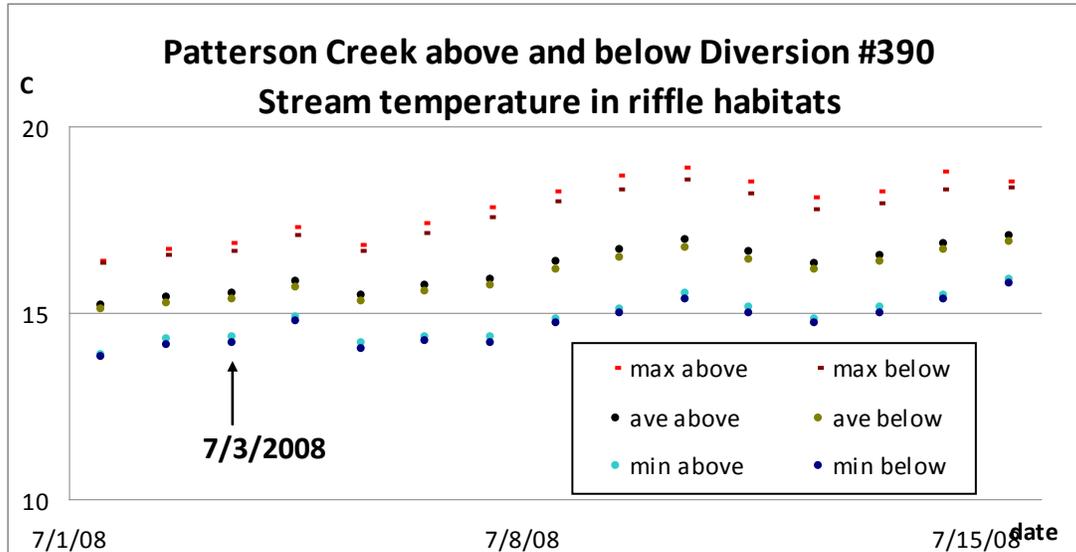
Graph 26 – Water Temperature above and below Diversion #390 before and after transaction– riffle habitats – 7/1/2008 – 7/15/2008.

Graph 26 shows the water temperature in riffle habitats above and below Diversion #390. On the 3<sup>rd</sup> of July, 1.0 cfs of water was returned to the instream flows of Patterson Creek. This additional water had either no affect on the water temperature below the point of diversion or potentially cooled the waters slightly in comparison to the upstream control. A negative affect on the temperature regime (e.g. warmer water at the downstream riffle) was not observed.

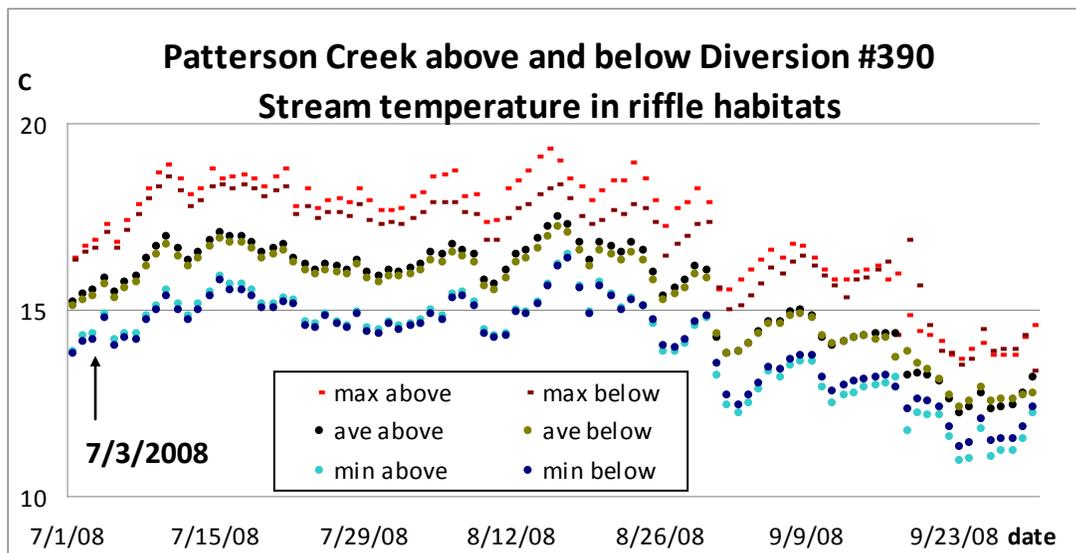
Graph 27 – Water temperature in Patterson Creek above and below Diversion #390 – riffle habitat – whole season.

with higher daily maximum occurring at the upstream riffle in comparison to the downstream riffle. A peak temperature of 19.3° C was recorded in the upper riffle on August 15<sup>th</sup> at 15:14. At this same time a temperature of 18.0° C was recorded in the downstream riffle. It is hypothesized that this depression in peak temperatures is due to stream water entering and leaving a large cobble/boulder bar that is below the point of diversion and directly above the downstream monitored riffle. The fish screen's bypass also runs through this bar and is potentially adding to the infiltration and cooling.

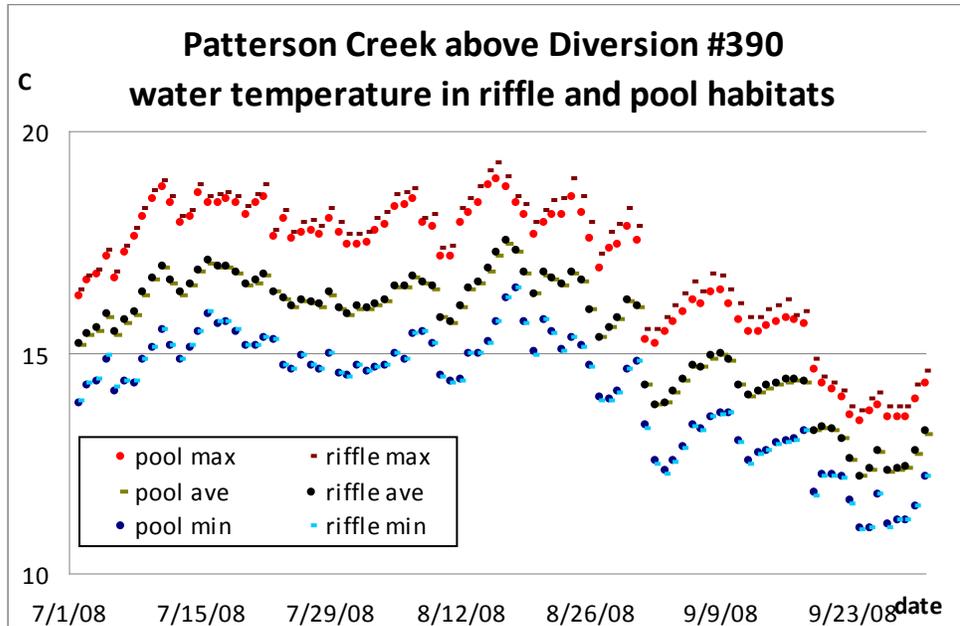
Graph 28 - Patterson Creek above Diversion #390 – water temperature in a pool and riffle habitat

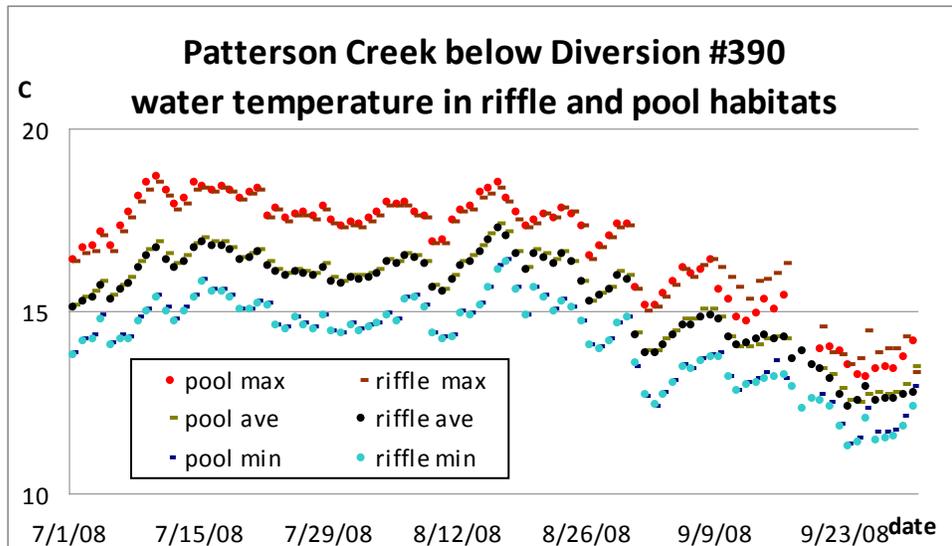
Graph 29 – Patterson Creek below Diversion #390 - water temperature in pool and riffle habitats

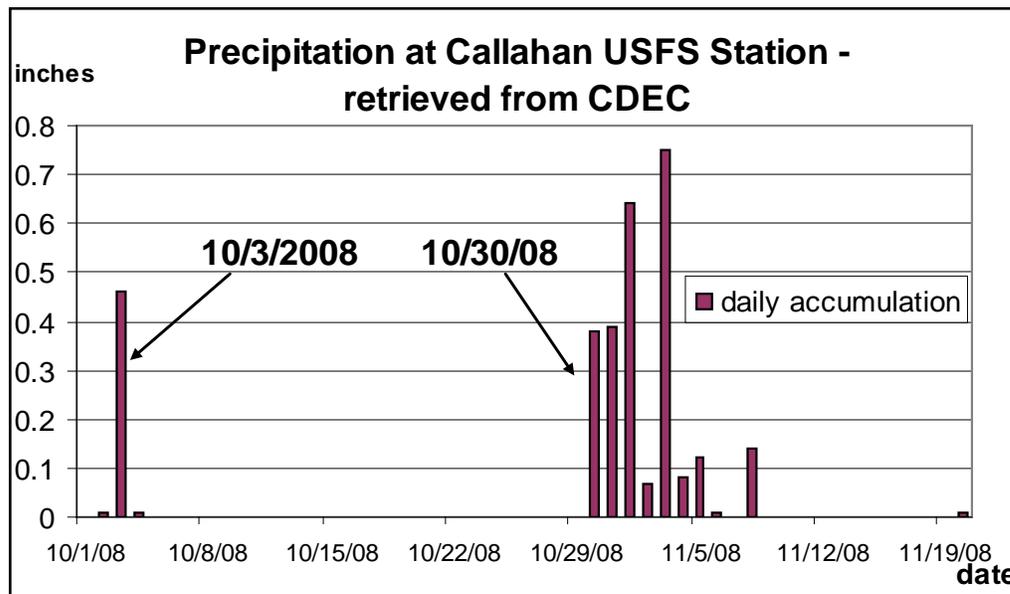
Graph 30 - Daily accumulated precipitation at the USFS Station in Callahan – data retrieved from [cdec.water.ca.gov](http://cdec.water.ca.gov) on 3/12/2009.

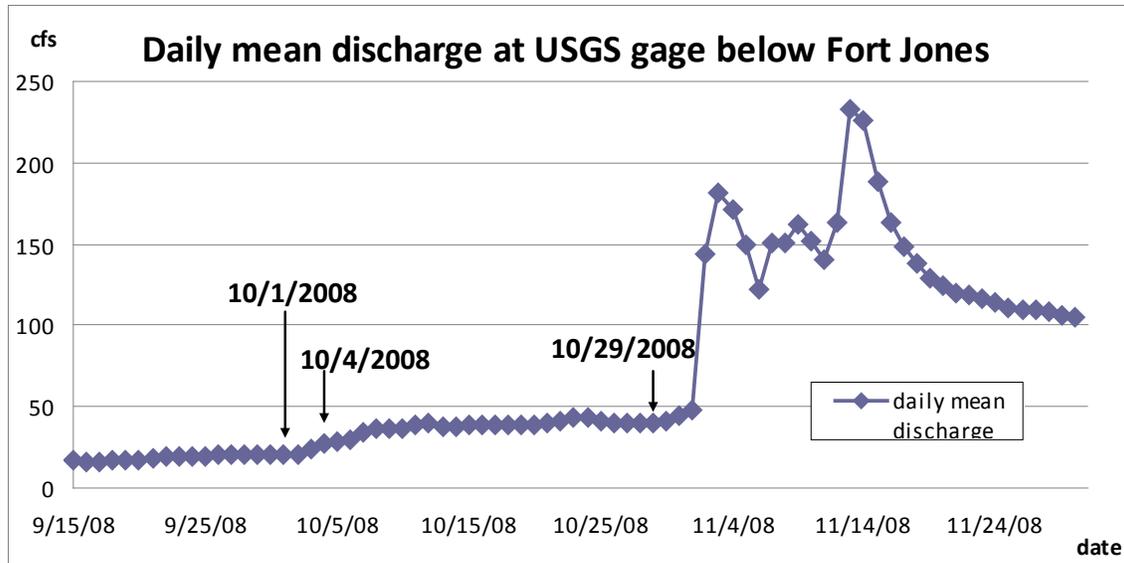
A series of fall leases were performed on adjudicated water rights in the main stem Scott River to improve the instream flows of the Scott River to aid the upstream migration of Chinook salmon and increase the possibility of Chinook accessing the spawning grounds located in the Scott Valley. A small precipitation event in early October and a much more significant and long lasting precipitation event in late October – Early November (Graph 30) occurred in the same time period as the fall lease amounts. This combination of natural increases in flow concomitant with the leasing of diverted waters increases the difficulty of monitoring the effect and persistence of leased instream flows (Graph 31 and Table 6).

Graph 31 – Certified daily mean discharge at USGS gage below Fort Jones data retrieved from USGS Real Time Water Data Website at:

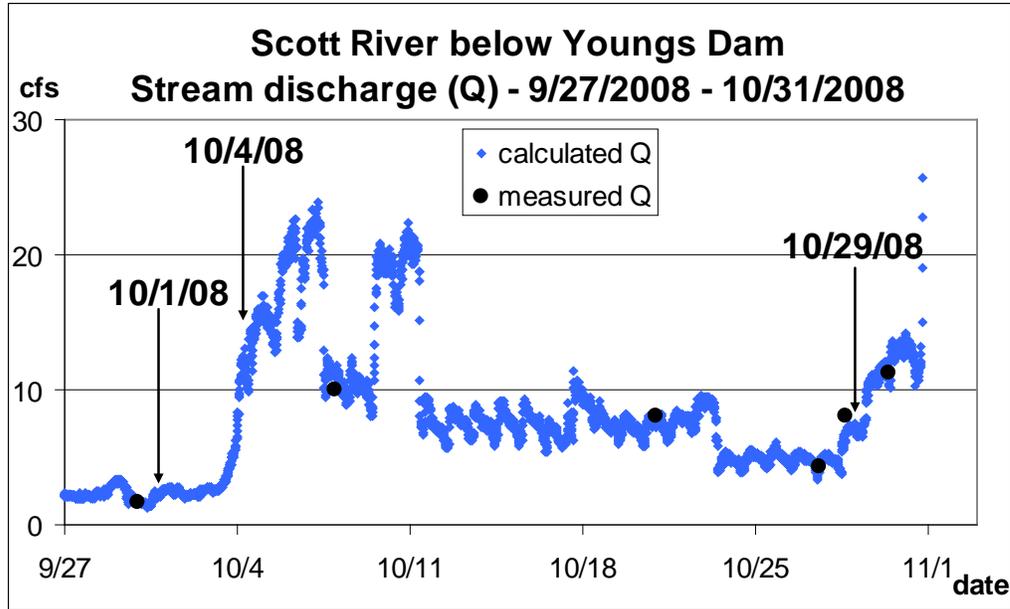
Graph 28 – Flow below Youngs Dam with dates of Water Trust transactions indicated

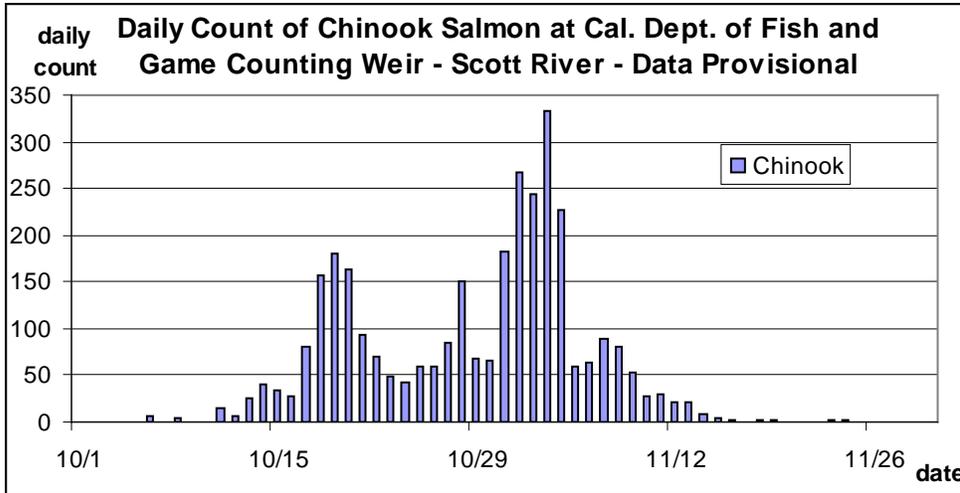
Graph 30 – Daily Chinook counts at Scott River Video Weir – Provisional data courtesy of Morgan Knechtle – CDFG - Yreka

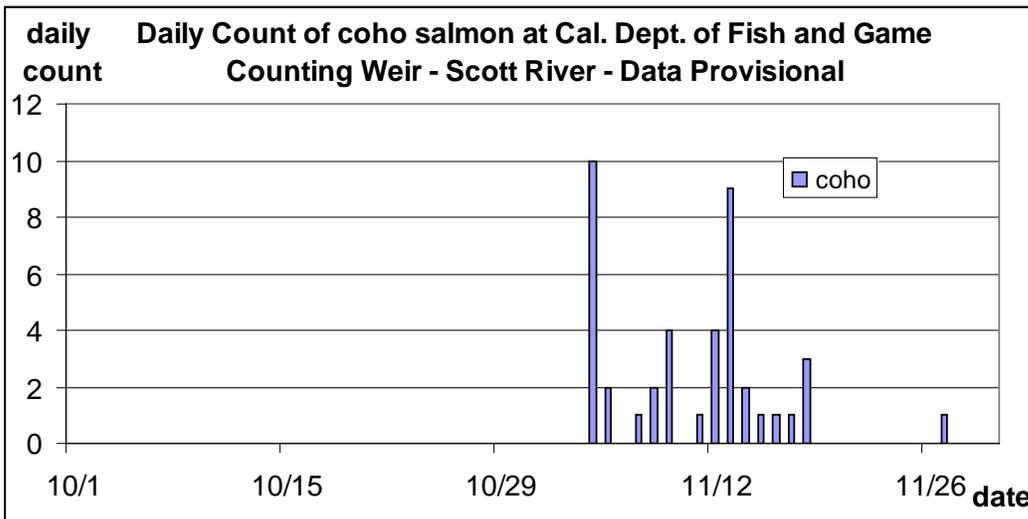
Graph 31 – Daily coho counts at Scott River Video Weir – Provisional data courtesy of Morgan Knechtle – CDFG - Yreka
